SC-8334  
SC-8334

HALLOWELL 0.83km

2021 Inspection

CBR iPad Offline Ver 0.34 - DSC

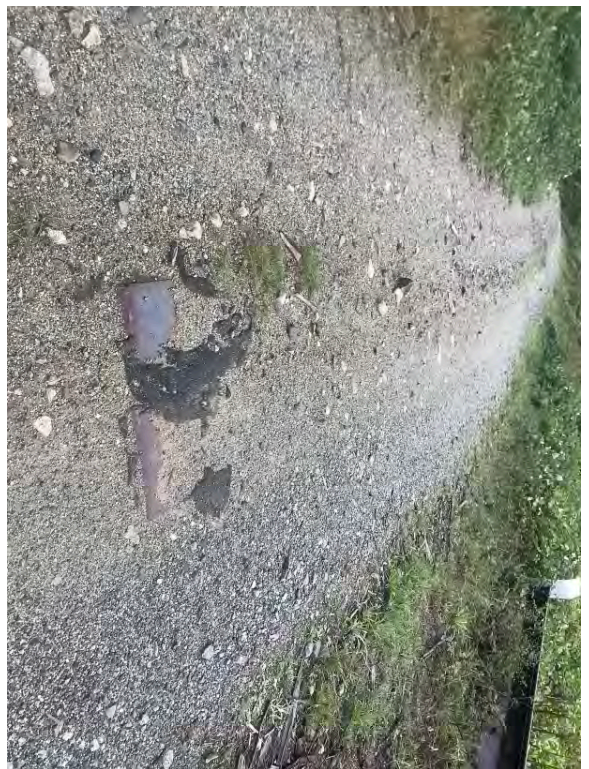
Deck

Gravel Surface      Poor      Missing on left abutment side

| 1 | Structure. Add Fill Cover. # of items. Priority:Low | Add gravel to deck |

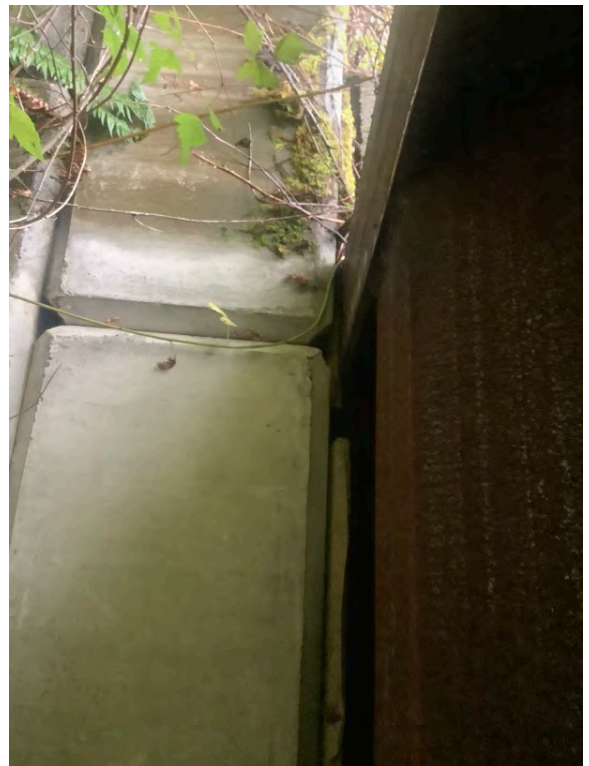
Bearing

Bearings Fair Treated timber sills, crushing. Monitor

| Item | Monitor Description | Frequency |
|---|---|---|
| 1 | Monitor sills | Routine Inspection |
