SC-8354  
SC-8354

## SECHELT GRAY 0.2km

2021 Inspection

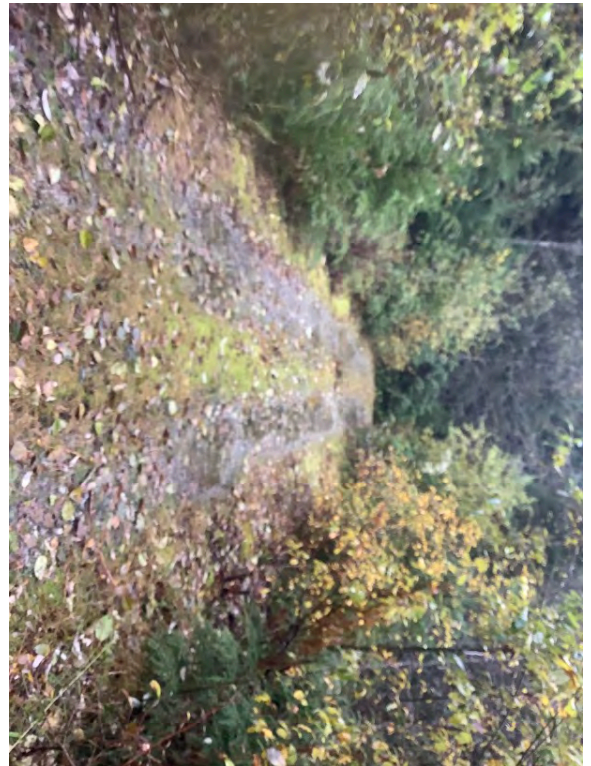
Approach from Right Bank when facing downstream

Road Surface Poor Large cross ditches. 4x4 access only

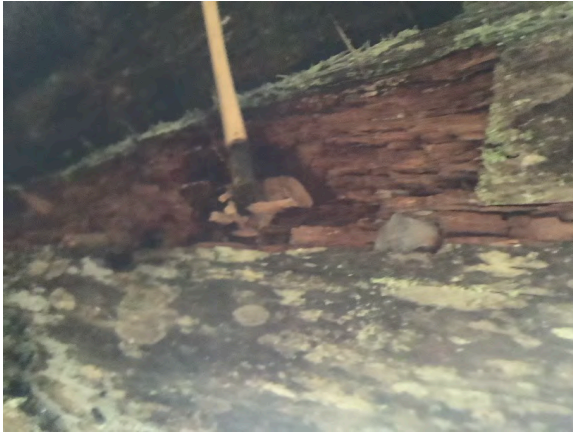
Stringer 1

Girders Poor Rotten, 200+mm rot.

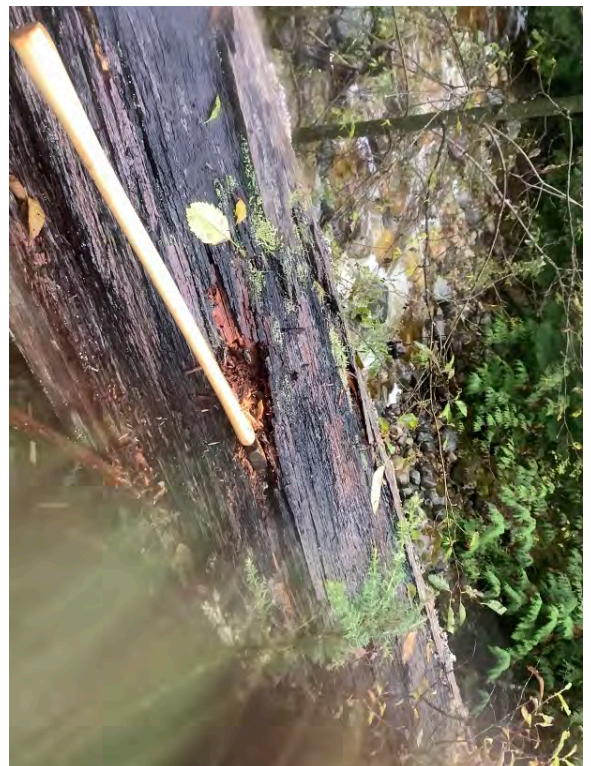
Stringers have 200+mm rot in some cases. Some stringers (i.e. stringer #2) have signs of splitting at midspan.

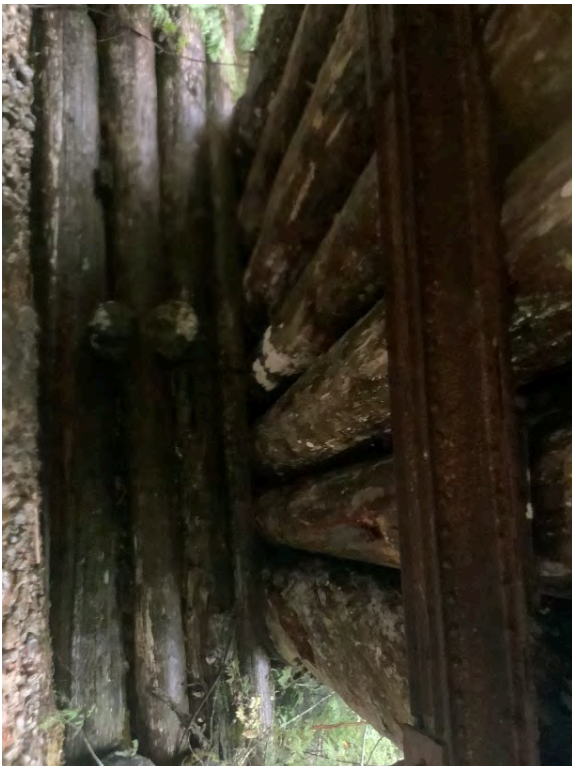
Left Bank Abutment when facing downstream

Log/Timber Cribs Poor Old rotten cribs, undermined

Tie Backs Poor Rotten
