SC-8514  
SC-8514

DUCK LAKE 4.89km

2021 Inspection

| Structure Class | Major Culvert |

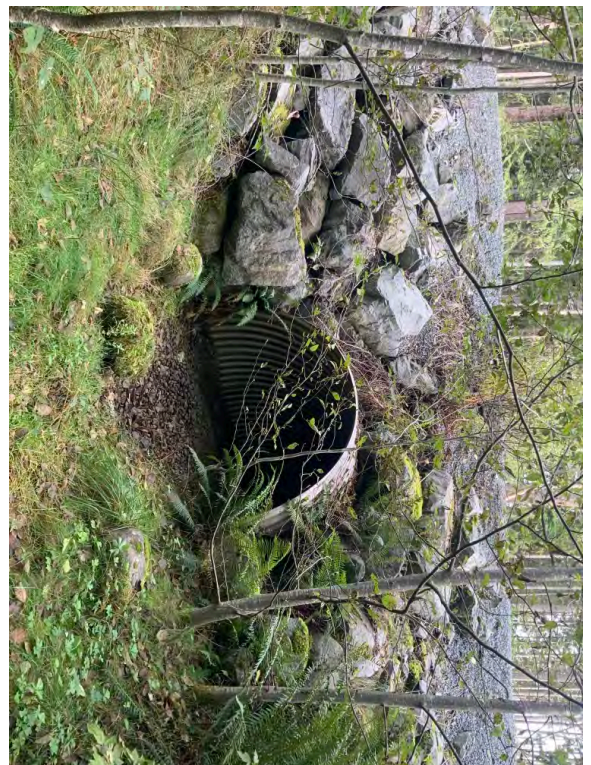
Inlet      Good

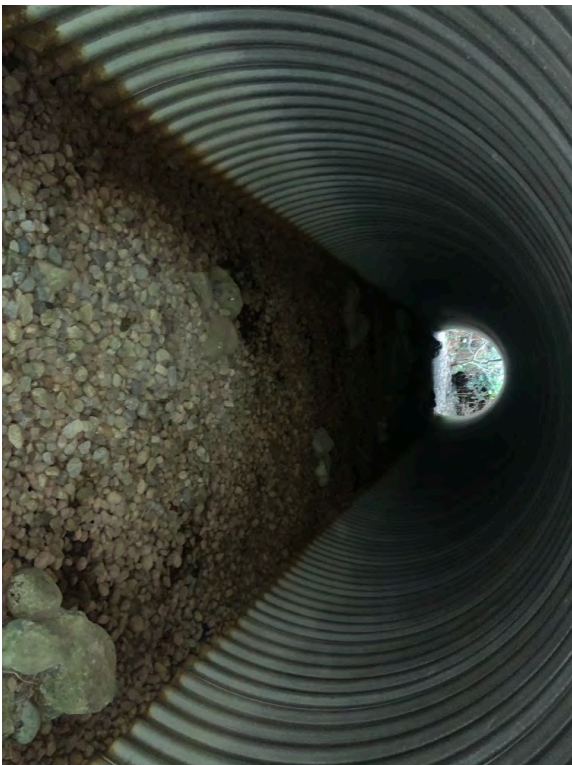
Culvert Floor

Floor      Unrated      Embedded

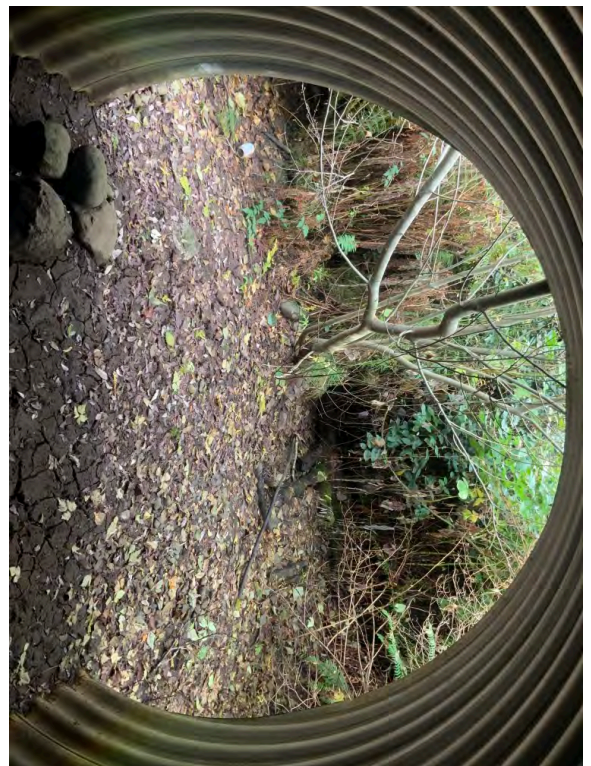
Outlet      Good
