SC-8518  
SC-8518

## SALTARY-FAIRVIEW 0.8km

2021 Inspection

| Crossing Name | Rainy Day Creek |

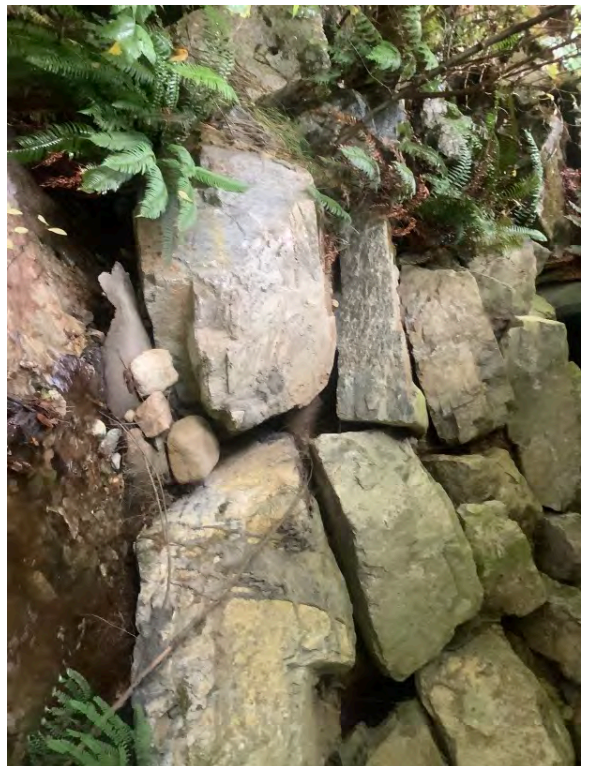
Riprap Fair Scour ds right side. Monitor.

Ds right riprap scour

| Item | Monitor Description | Frequency |
|---|---|---|
| 1 Riprap ds right side | | Routine Inspection |
