SC-8565  
SC-8565

MCNAB 2.3km

2021 Inspection

CBR iPad Offline Ver 0.34 - DSC

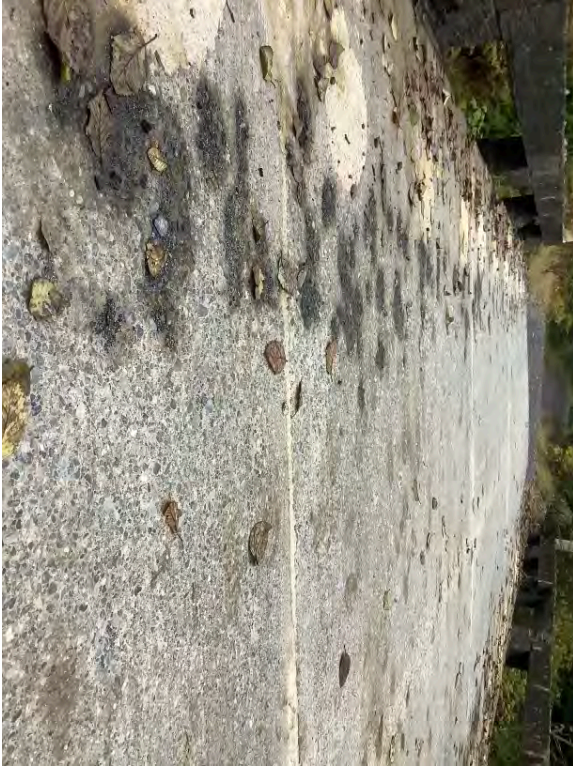
| Item | Monitor Description | Frequency |
|---|---|---|
| 1 | Monitor deck - excavator damage | Routine Inspection |

Deck - damage from excavator walking on deck

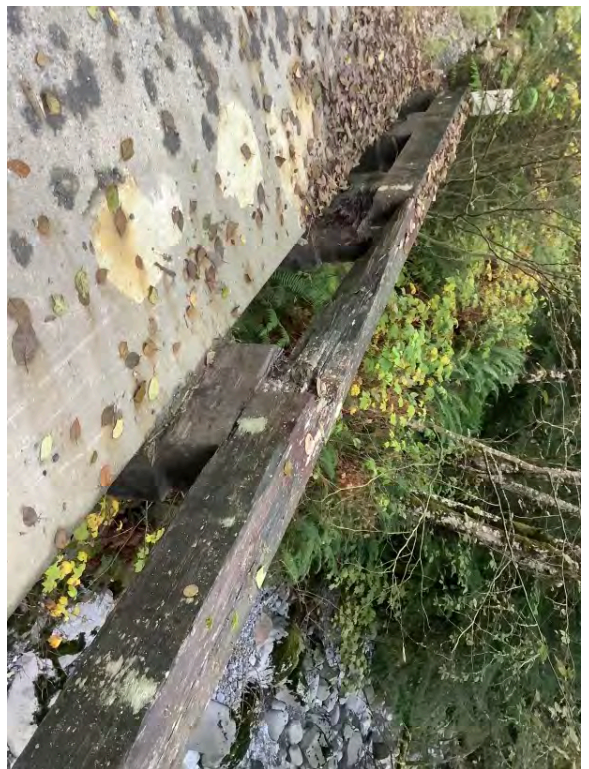
Guard Rail

Curb Rail/Blocks/Posts      Poor      Rotten. Replace.

Load Rated by: Richard Mills, P.Eng. Nov 18, 2021  
Load Rating: L165 or 150 tonnes  
Next Inspection: 2024  
Comments: Replace guardrails.

| 1 | Structure. Full Curb Replacement. .<br>Priority:High |
