SC-8625  
SC-8625

SR02-027 0.31km

2021 Inspection

CBR iPad Offline Ver 0.34 - DSC

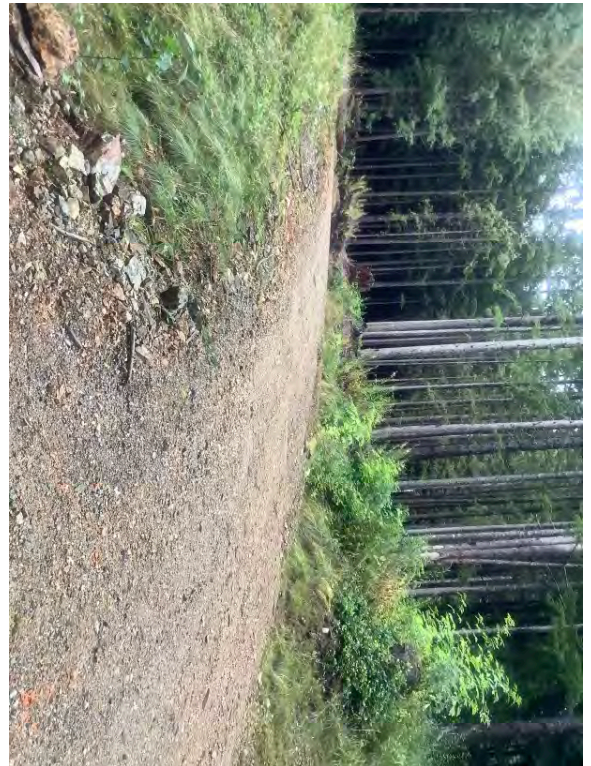
Road access blocked. Confirm permanent deactivation.

Road access blocked

Comments: Post load rating and advise users. Confirm structure has been deactivated and access blocked.
