SC-8638  
SC-8638

## SECHELT ROBERTS 0.85km

2021 Inspection

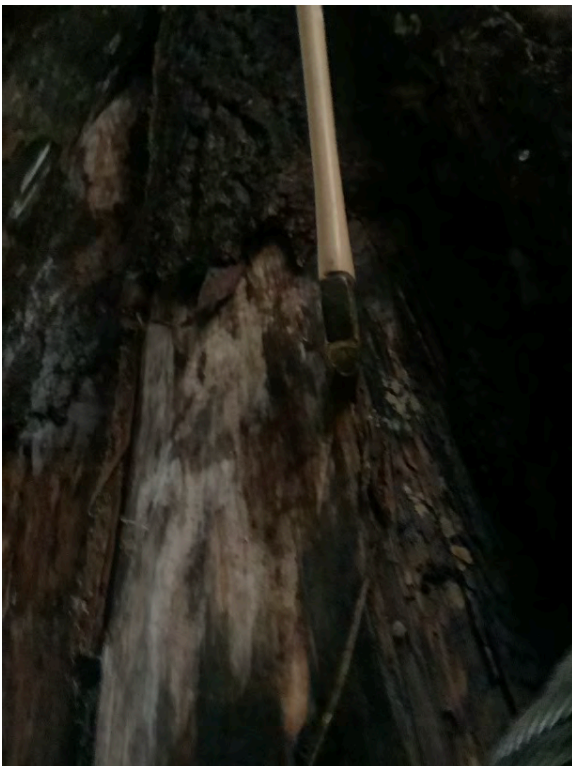
Older 2nd growth fir bridge. Stringers showing conk, up to 100mm sap rot on some stringers. Replace prior to industrial use.

Girders Poor Significant sap rot, conks on stringers

Comments: Pickup access only. Advise users and post load rating.

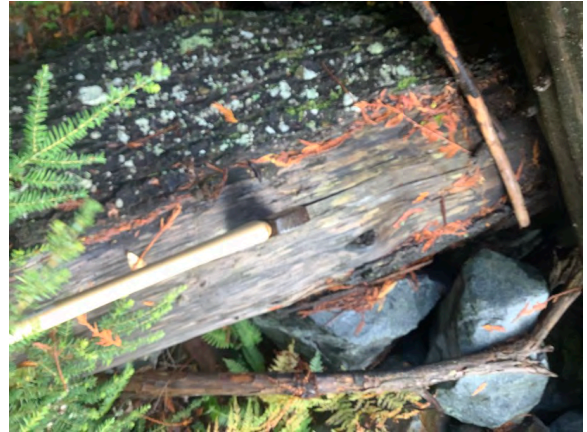
Sill

Caps or Sills Poor Sap rot
