SC-8639  
SC-8639

SECHELT ROBERTS 1.06km

2021 Inspection

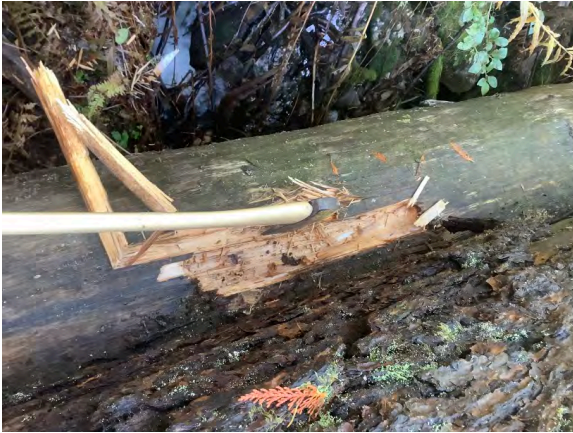
Stringers have konk, 100mm plus sap rot. Downrate

Girders Poor Conk, sap rot

Stringer - typical rot

Load Rated by: Richard Mills, P.Eng. Oct 21, 2021  
Load Rating: 5 tonnes  
Next Inspection: 2022  
Comments: Pickup access only. Advise users and post load rating.

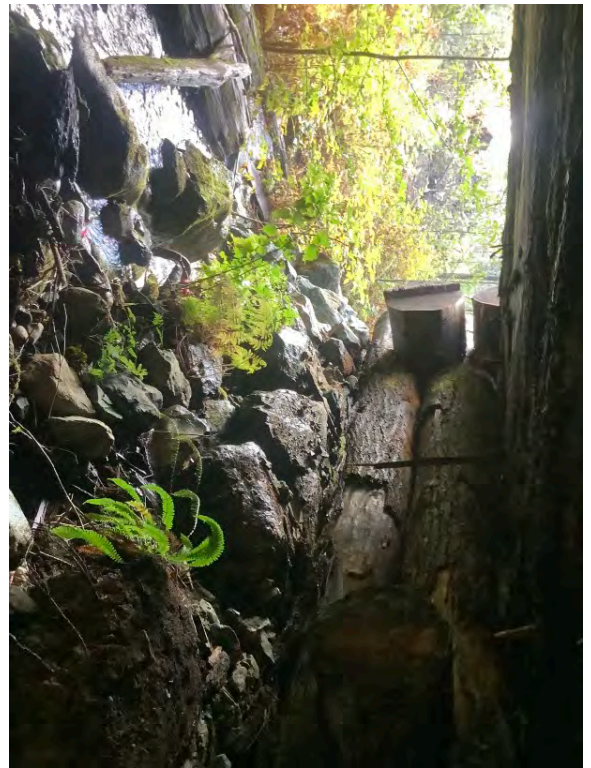
Log/Timber Cribbs Poor Undermined, conk

Left Bank Abutment when facing downstream - undermined
