SC-8640  
SC-8640

## SECHELT ROBERTS 1.12km

2021 Inspection

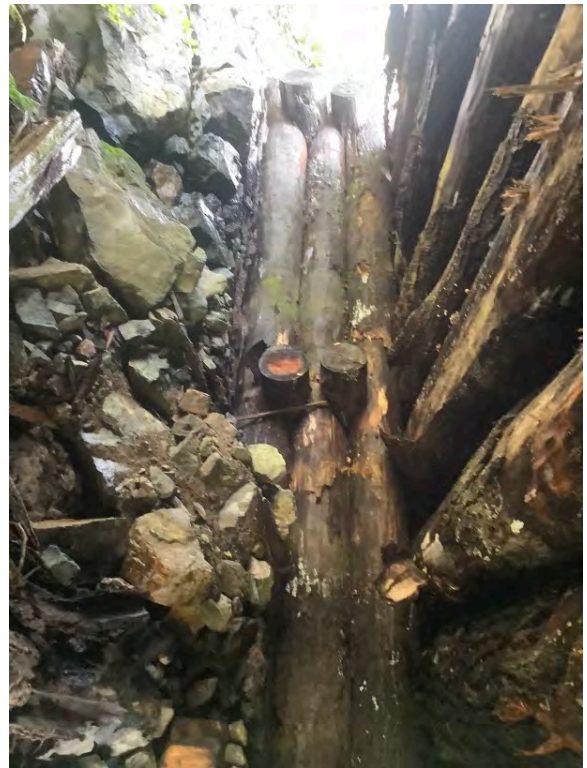
Tiebacks - typical rot

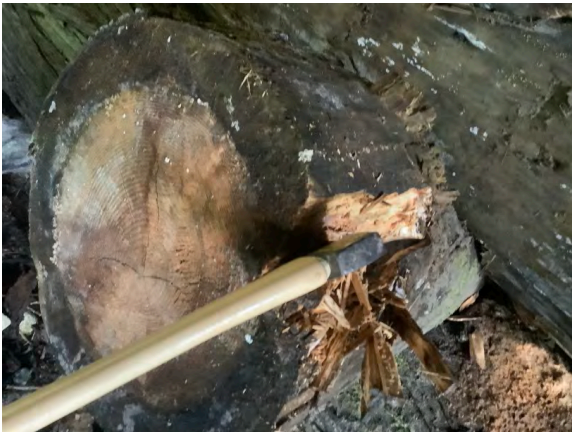
Stringers have 100mm sap rot, conks. Replace prior to industrial use. Max pickup only recommended

Conk, approx 100mm sap rot ave overall

Load Rated by: Richard Mills, P.Eng. Oct 21, 2021  
Load Rating: 5 tonnes  
Next Inspection: 2022  
Comments: Pickup access only. Advise users and post load rating.

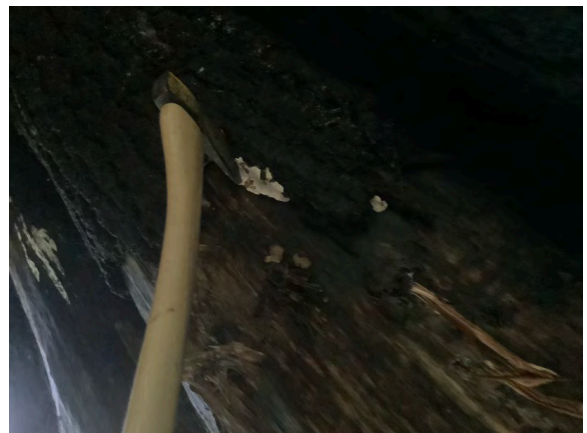
Stringers - conk
