SC-8040  
SC-8040

HOMATHKO 9.8km

2022 Inspection

Crossing Name Smith Creek

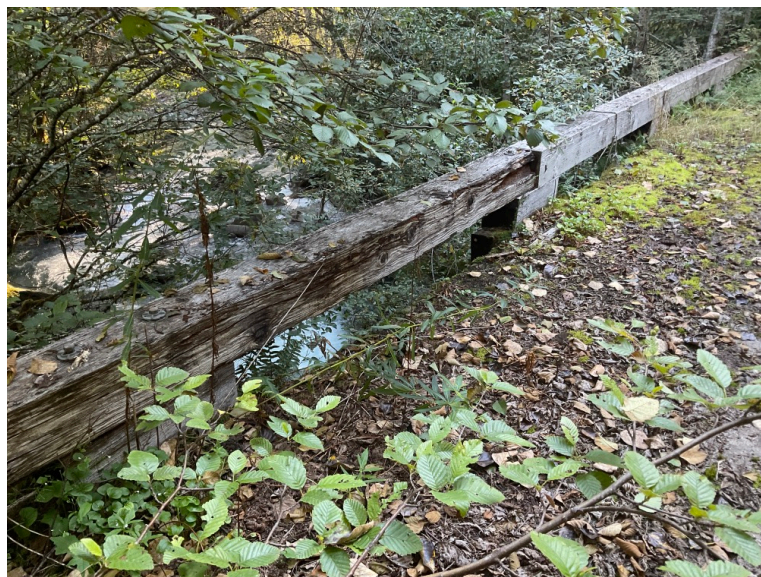
Guard Rail

Curb Rail/Blocks/Posts Poor Rotten, replace

Site is inaccessible by vehicles, had to hike from mouth of creek up 400m to crossing. Recommend district not to P.Eng inspect bridge until access is restored. Reduce load rating until guardrails replaced

| Repair Item | Repair Description |
|---|---|
| 1 Structure. Full Curb Replacement. 40 . Priority:Medium | Replace guardrails |
