SC-8041  
SC-8041

HOMATHKO 12.7km

2022 Inspection

Crossing Name Falls Creek

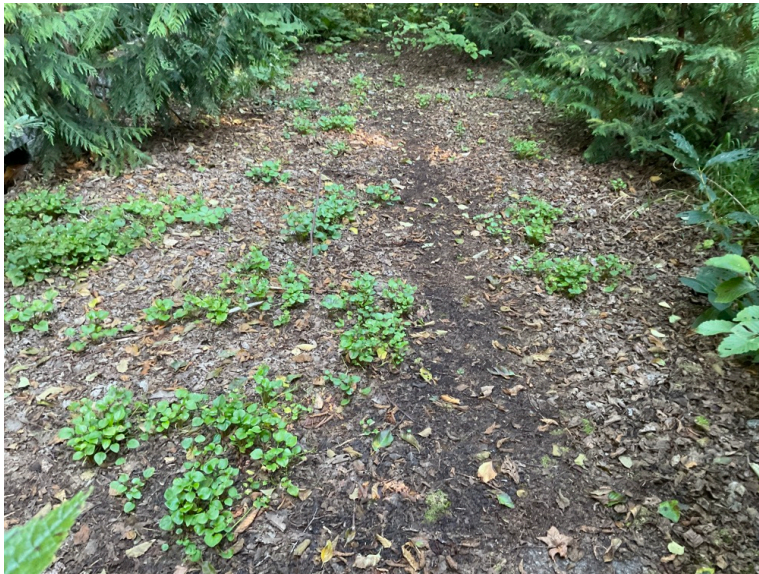
Grout Pockets Unrated Covered in debris

Deck Joints Unrated Covered in debris

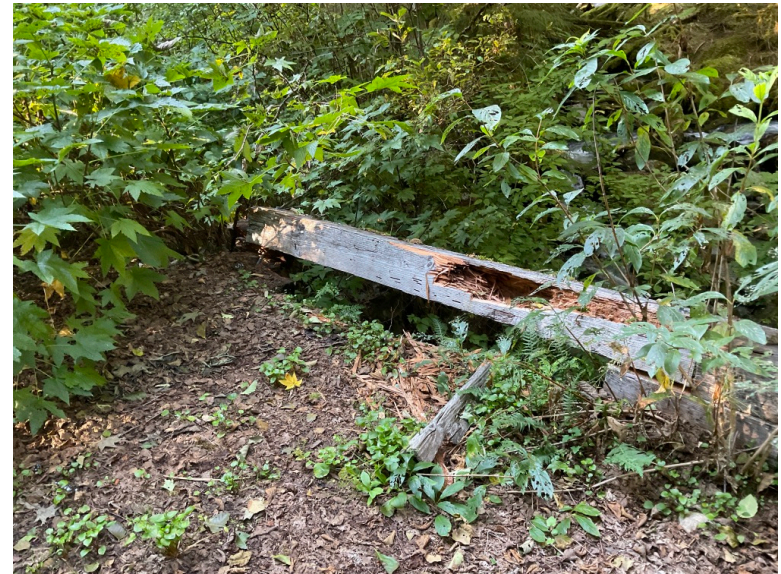
Guard Rail

Site is inaccessible by vehicles, had to hike from mouth of creek up 200m to crossing. Recommend district not to P.Eng inspect bridge until access is restored. Reduce load rating until guardrails replaced

Curb Rail/Blocks/Posts Poor Rotten and fallen off

Overall Deck Condition Poor Guardrails

| 2 Structure. Full Curb Replacement. 40 . Priority:High | Replace guardrails |
