SC-8043  
SC-8043

HOMATHKO 3.3km

2022 Inspection

Crossing Name Cumsack Slough

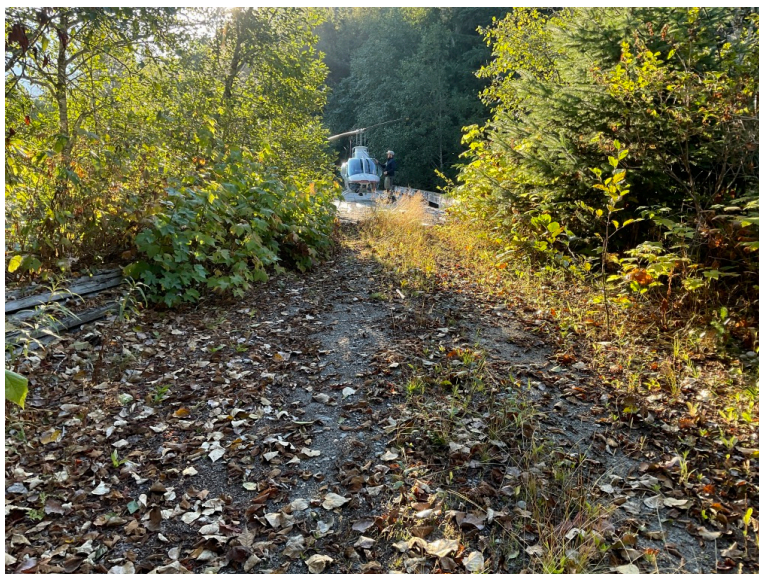
Approach from Left Bank when facing downstream

Brushing Required Y Brushy

Delineator Missing  
Left ☐ 0 ☐ 1 ☒ 2

Delineator Missing  
Right ☐ 0 ☐ 1 ☒ 2

| Repair Item | Repair Description |
|---|---|
| 1 Approach. Area/sight line brushing. 20 m <sup>2</sup> . Priority:Low | Brush sight lines when active |
| 4 Approach. Add Warning Signs. 4 # of signs. Priority:Low | Add delineators |

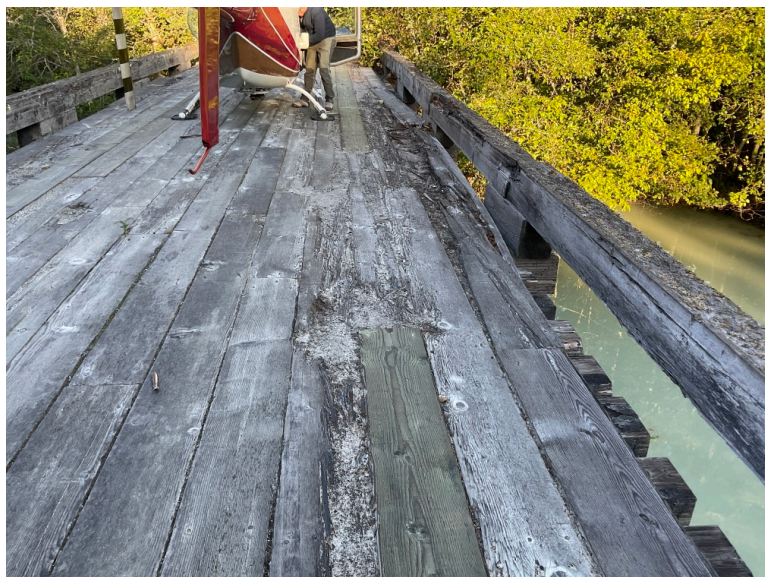
| Running Surface | Poor | |
| Running Planks | Poor | Rotten |
| Overall Deck Condition | Poor | Replace |

| Repair Item | Repair Description |
|---|---|
| 3 Structure. Minor redecking (wearing surface). 200 m. Priority:Medium | Replace wear deck |

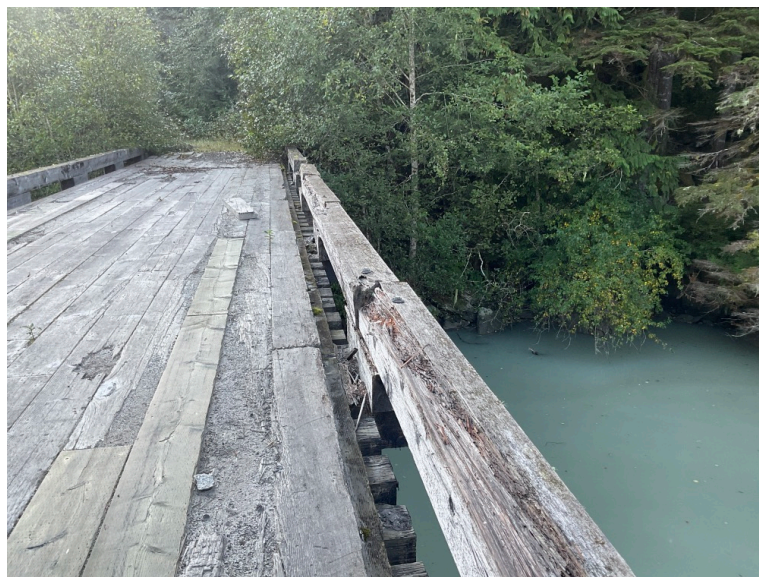
Guard Rail

Down rate until guardrails have been replaced. Post load rating signs.

| Curb Rail/Blocks/Posts | Poor | Rotten and falling off |

| Repair Item | Repair Description |
|---|---|
| 2 Structure. Full Curb Replacement. 80 . Priority:High | Replace guardrails |

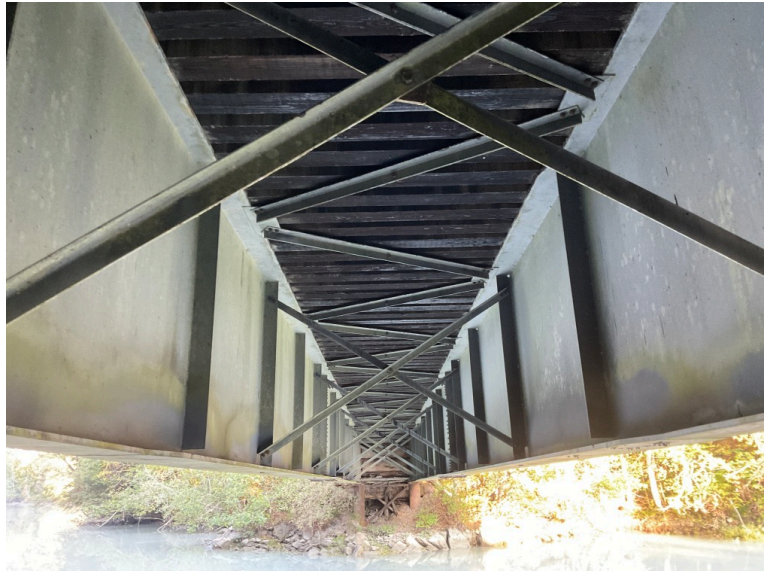
Superstructure

Girders Fair Very minimal corrosion
