SC-8077  
SC-8077

## MISERY CREEK 8.2km

2022 Inspection

Load Rated by: Richard Mills, P.Eng. Jan 24, 2023  
Load Rating: L150 or 136 tonnes  
Next Inspection: 2025

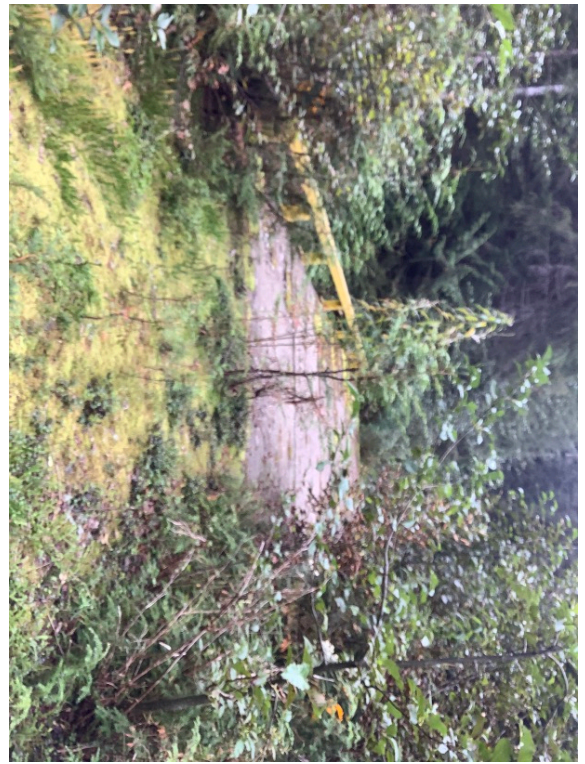
Approach from Left Bank when facing downstream

Brushing Required **Y** **Very brushed in**

Road Surface **Poor** **Alderred in**

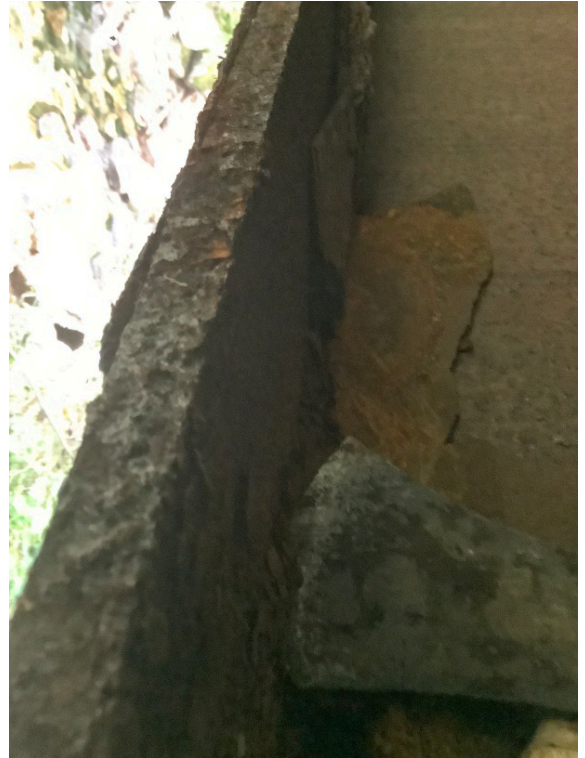
Rust scale in girders, near joints. No apparent change since last inspection.

Rust scale ds right abutment. Inside ds girder. Typical.

| Item | Monitor Description | Frequency |
|---|---|---|
| 1 | Monitor girder corrosion | Routine Inspection |
