SC-8120  
SC-8300-2

## SALTARY BAY 0.8km

2022 Inspection

Structure Class Major Culvert

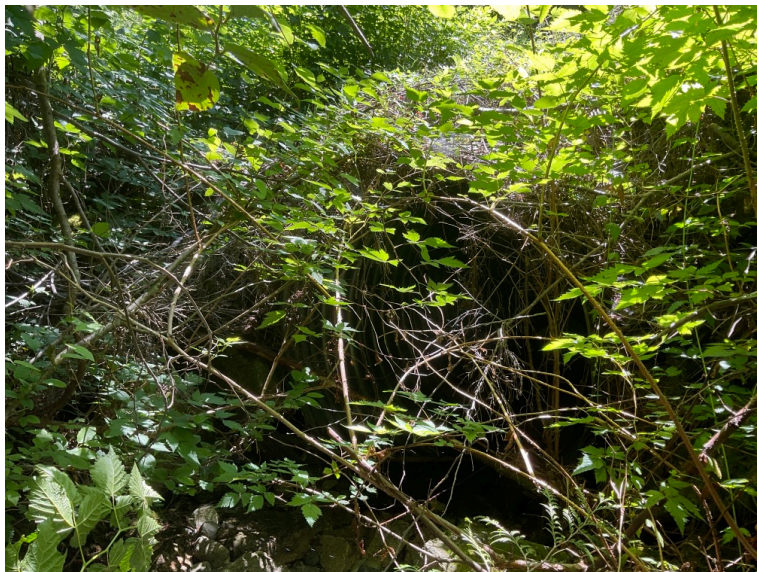
Inlet Fair

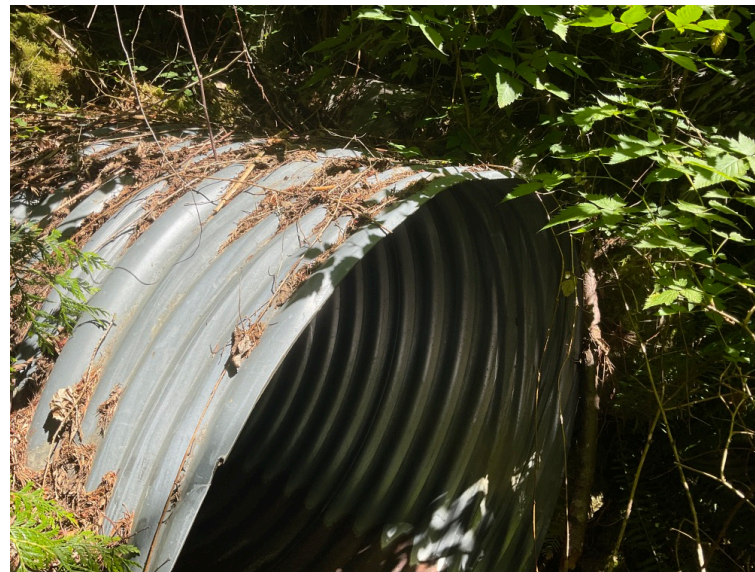
Outlet Fair

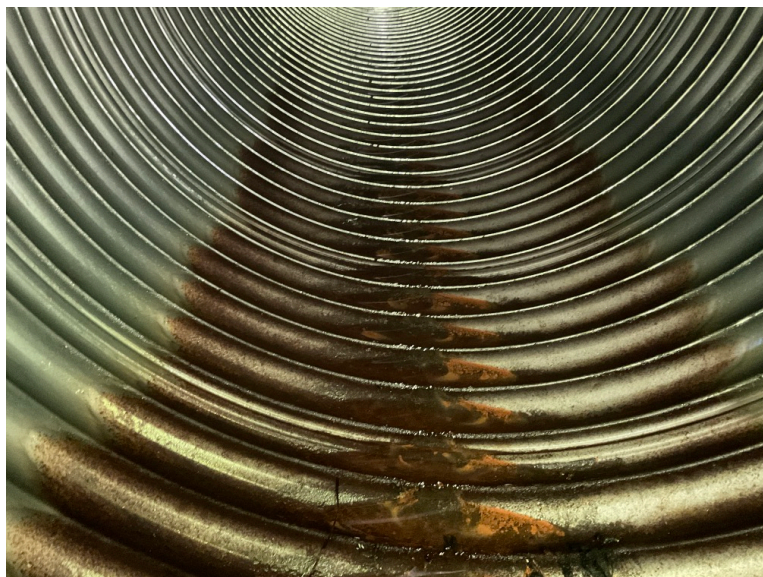
Culvert Floor

Floor Fair
