SC-8142  
SC-8142

SECHELT DAKOTA 27.1km

2022 Inspection

Structure Class Temporary Bridge

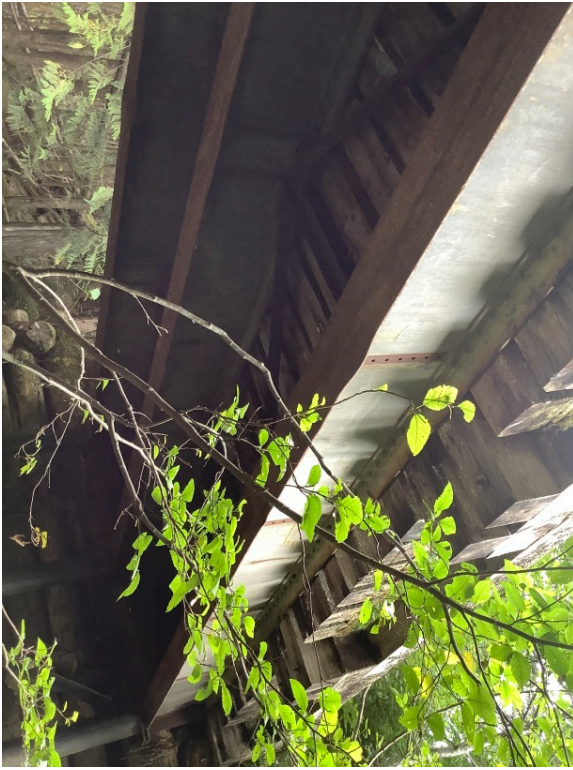
Superstructure

Girders Fair

Old riveted steel i beams.

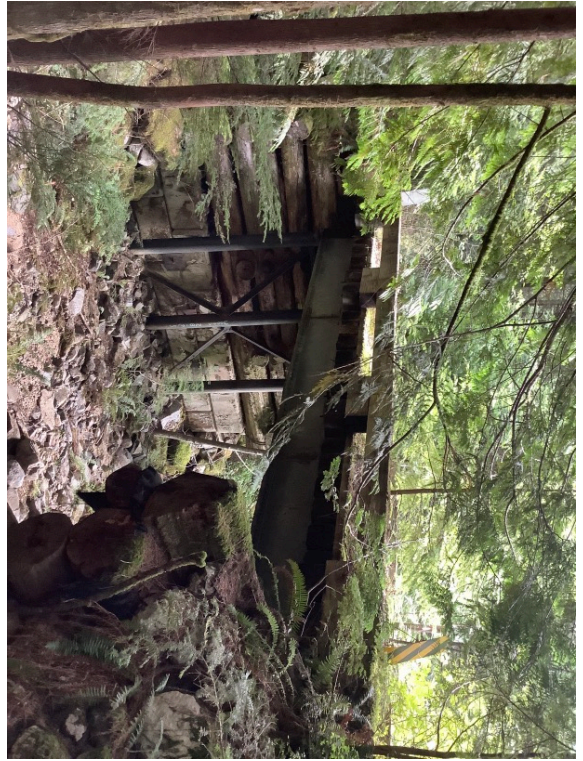
Left Bank Abutment when facing downstream

Log/Timber Cribs Fair Fill retention only

Tie Backs Fair Fill retention only

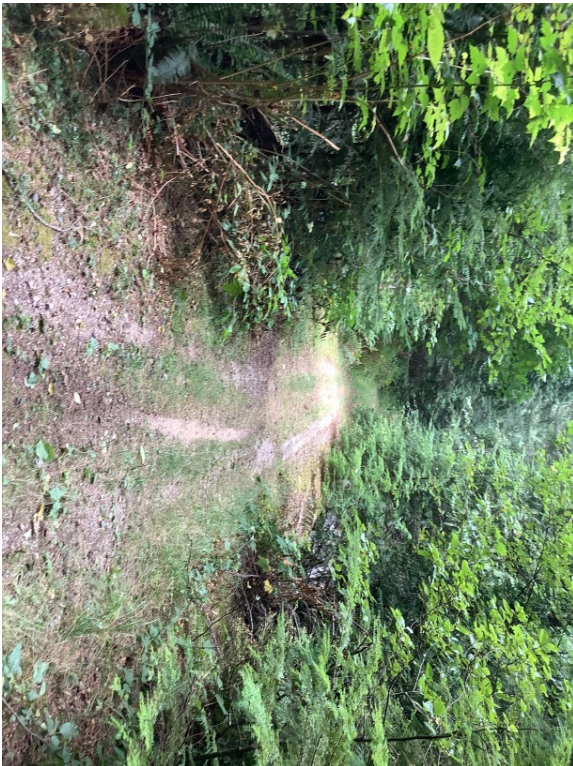
Approach from Left Bank when facing downstream

Road Surface Poor Partial deactivated, gated. 4x4 atv only.

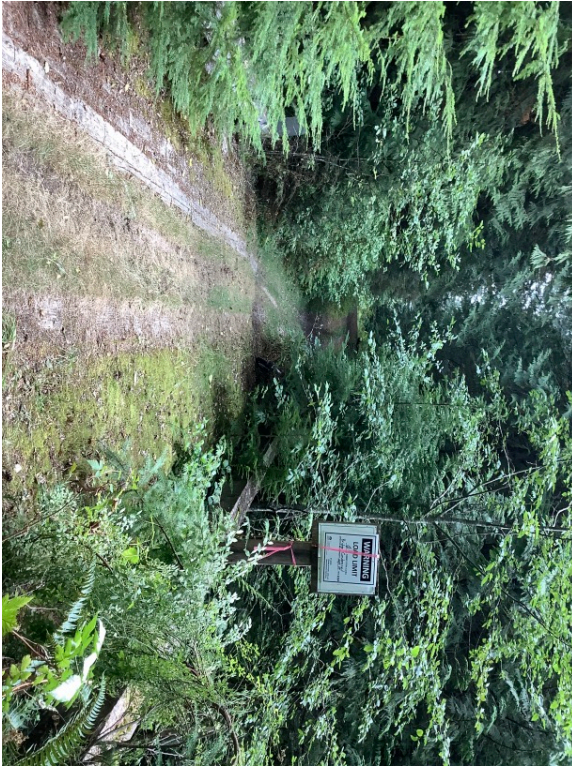
Load Rating Sign

Posted Load Rating 0 Condemned

Comments: Ensure access is blocked. Replace all timber deck components for light vehicle access, replace entire structure if needed for industrial use.

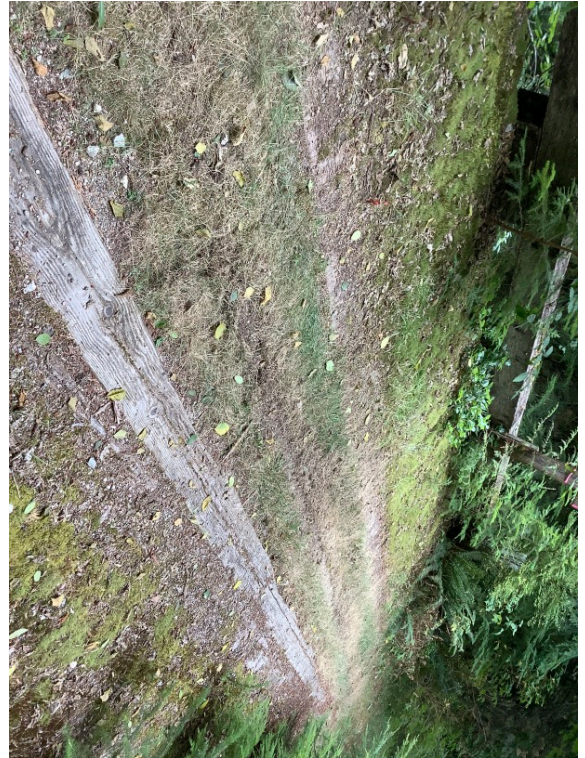
Running Planks      Poor      Rotten

Sub Deck      Poor      Rotten

Ties      Poor      Rotten

Nails      Poor      Loose

Overall Deck Condition      Poor      Rotten

| Repair Item | Repair Description |
|---|---|
| 2 Structure. Timber deck maintenance. # of signs. Priority:High | Replace deck, ties. Currently inaccessible to vehicle) |

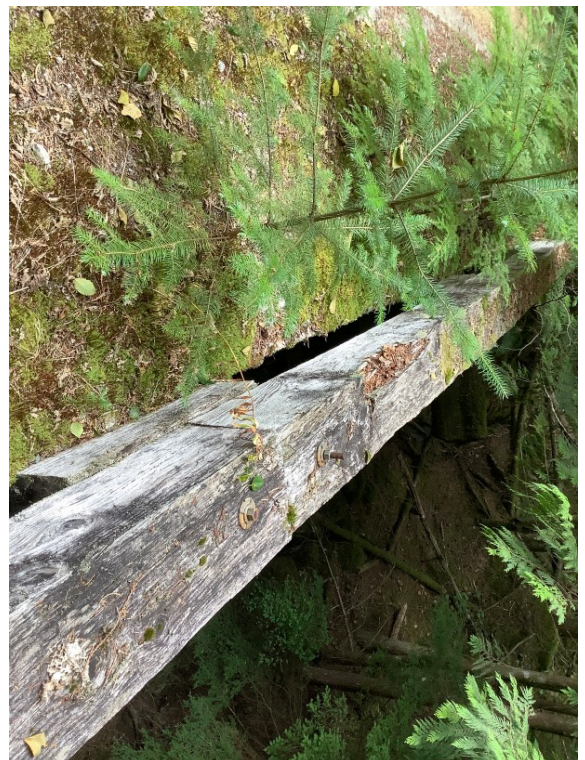
Guard Rail

Curb Rail/Blocks/Posts      Poor      Rotten

| Repair Item | Repair Description |
|---|---|
| 1 Structure. Full Curb Replacement. . Priority:High | Guardrails loose, rotten. |
