SC-8144  
SC-8144

SECHELT DAKOTA 35.8km

2022 Inspection

Crossing Name Angus Creek

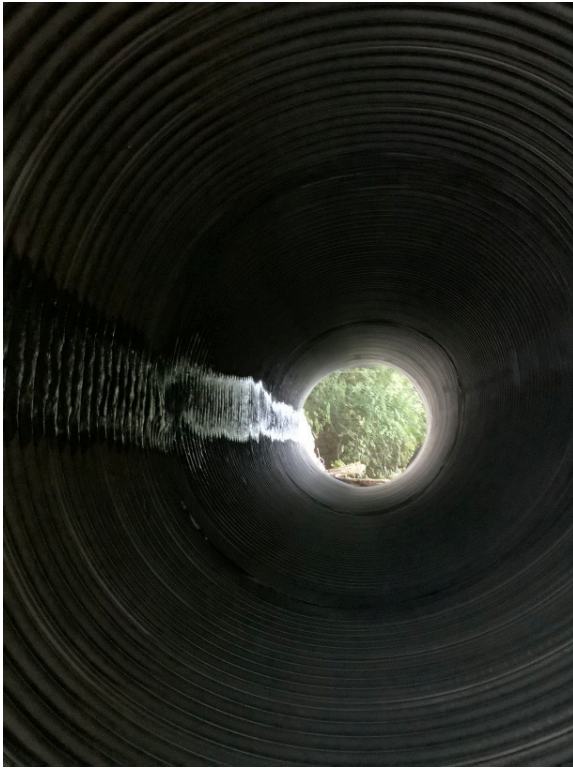
Inlet Fair Bedload on grizzley

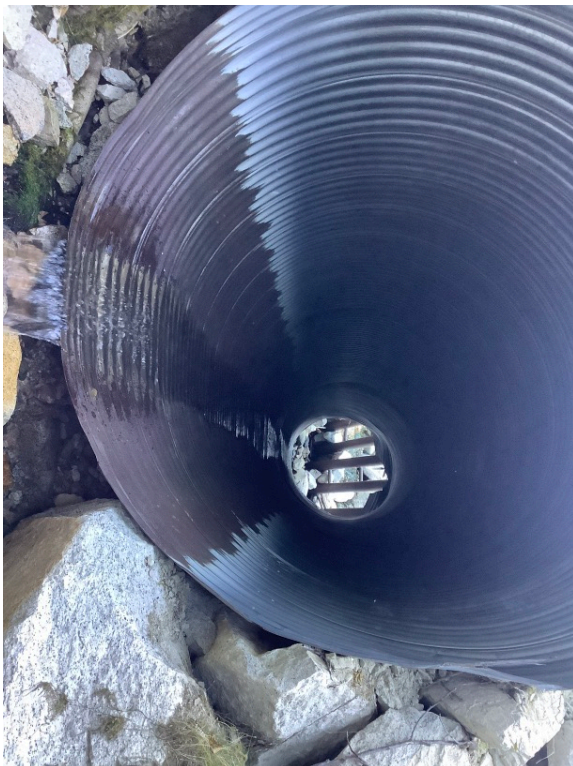
Outlet Good

| Repair Item | Repair Description |
|---|---|
| 2 Miscellaneous. Other (specify in comments). # of items. Priority:Medium | Cut excess culvert (blue paint line) |

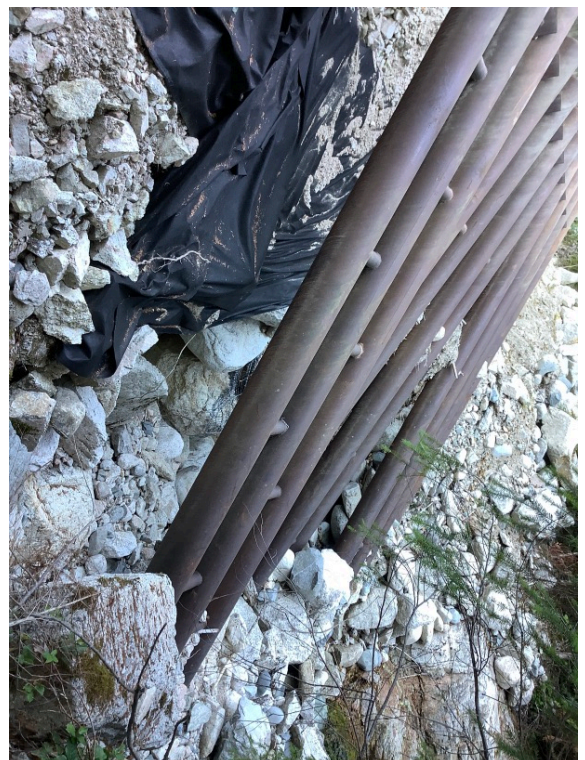
Grizzley

Trash Rack Fair 2 arms lower than rest. Reset.

| Repair Item | Repair Description |
|---|---|
| 3 Miscellaneous. Other (specify in comments). # of items. Priority:Medium | Re set grizzley arms and clear bedload |
