SC-8152  
SC-8152

SECHELT DAKOTA 39.66km

2022 Inspection

Crossing Name Gray Creek

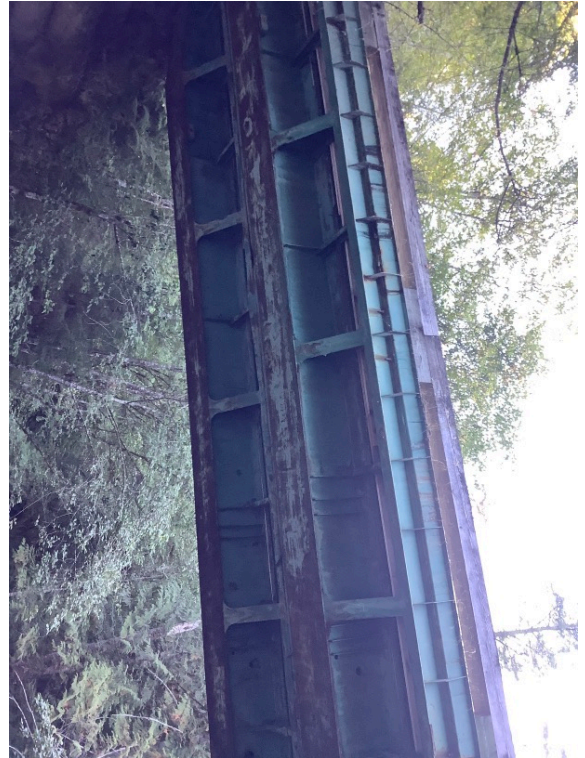
Superstructure

Surface corrosion on bottom flange.
