SC-8200  
SC-8200

THEODOSIA 0.1km

2022 Inspection

Superstructure Steel I-beam

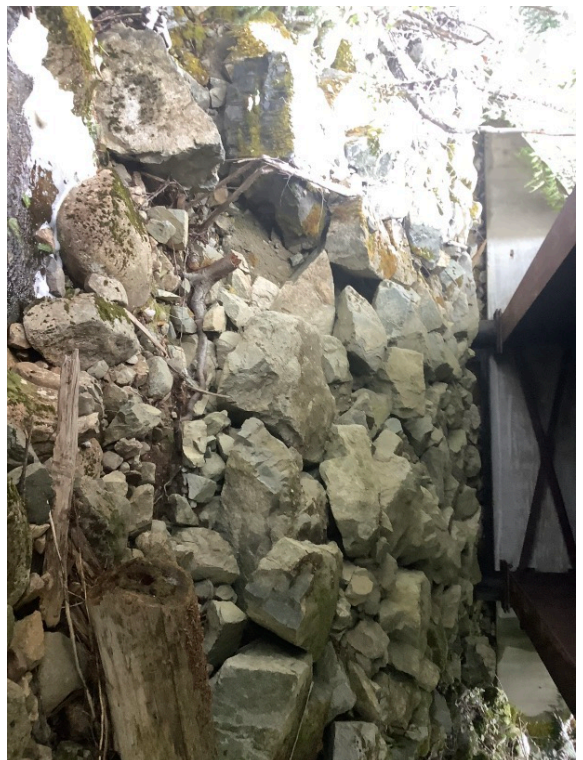
Right Bank Abutment when facing downstream

Right abutment is scoured, but footings are well back from stream channel. Monitor.

Riprap Fair Scoured right side

| Item | Monitor Description | Frequency |
|---|---|---|
| 1 | Monitor scour | Routine Inspection |
