SC-8203  
SC-8203

THEODOSIA 0.99km

2022 Inspection

Structure Class Major Culvert

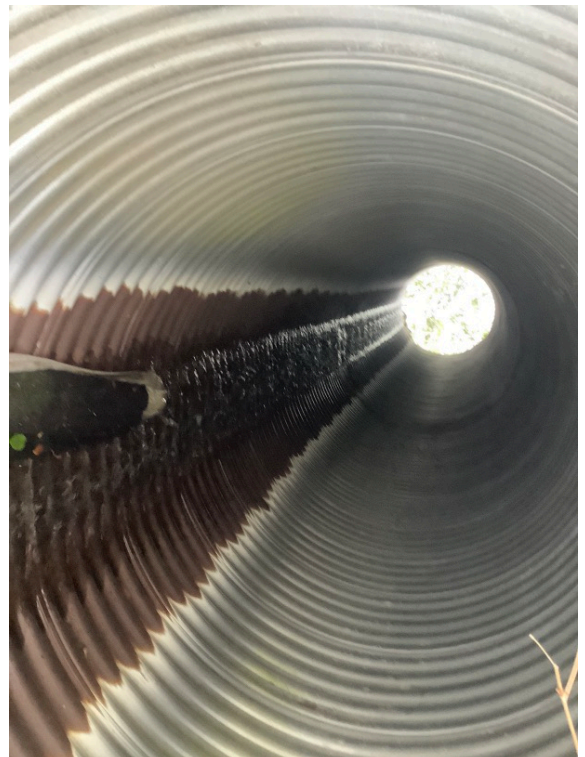
Inlet Good
