SC-8206  
SC-8206

## THEODOSIA 2.5km

2022 Inspection

Structure Class Major Culvert

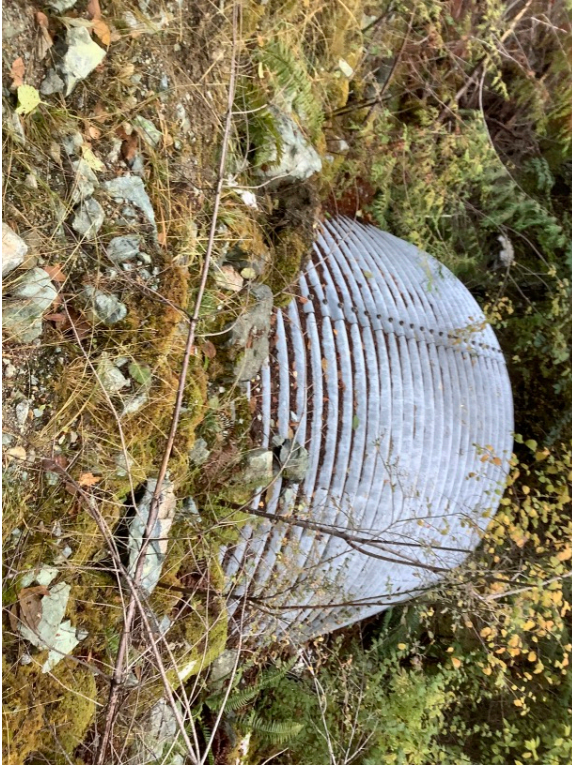
Outlet      Good

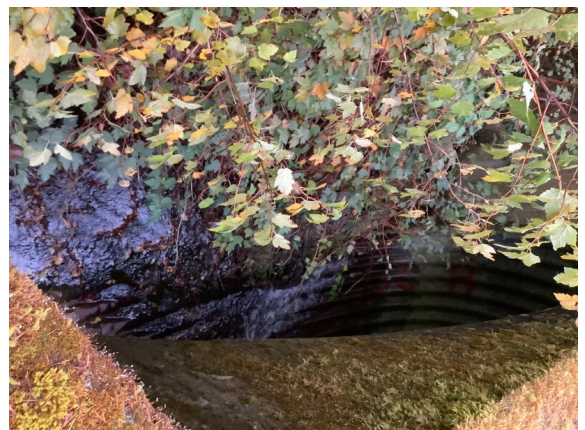
Inlet      Good

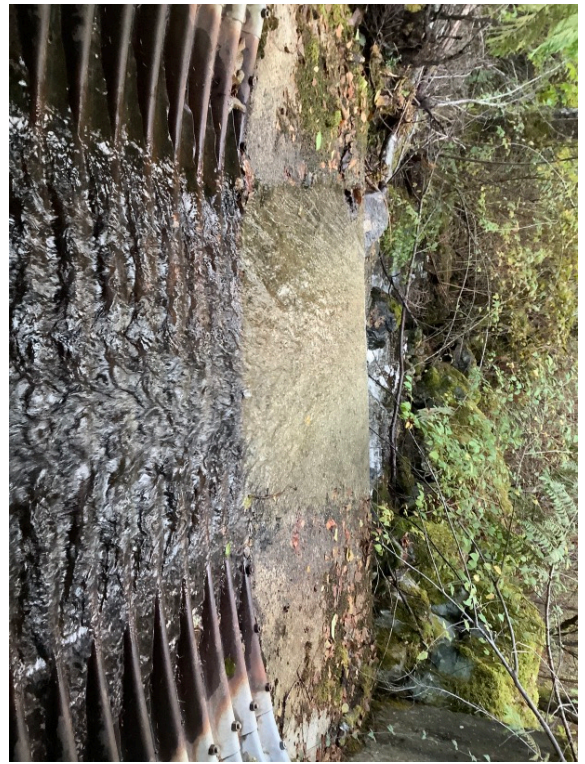
Culvert Floor

Coating      Fair      Floor starting to show scaling

Floor      Fair
