SC-8208  
SC-8208-2

THEODOSIA 3.3km

2022 Inspection

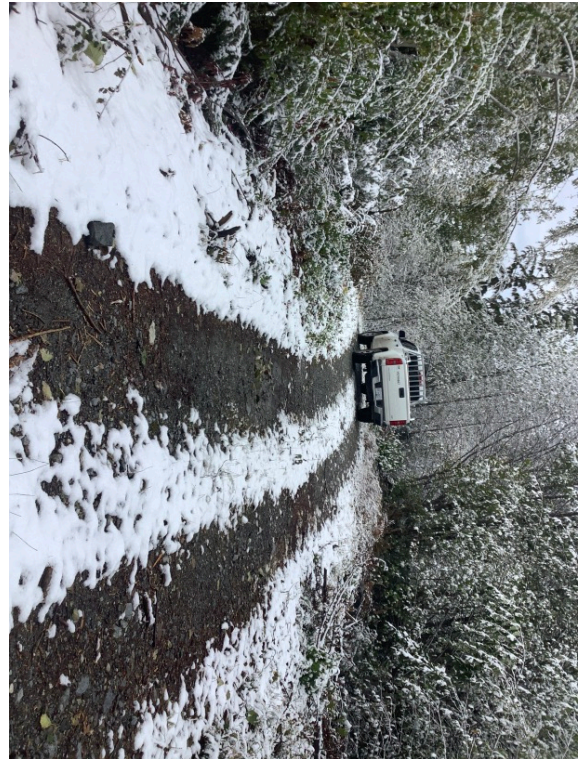
Approach from Left Bank when facing downstream

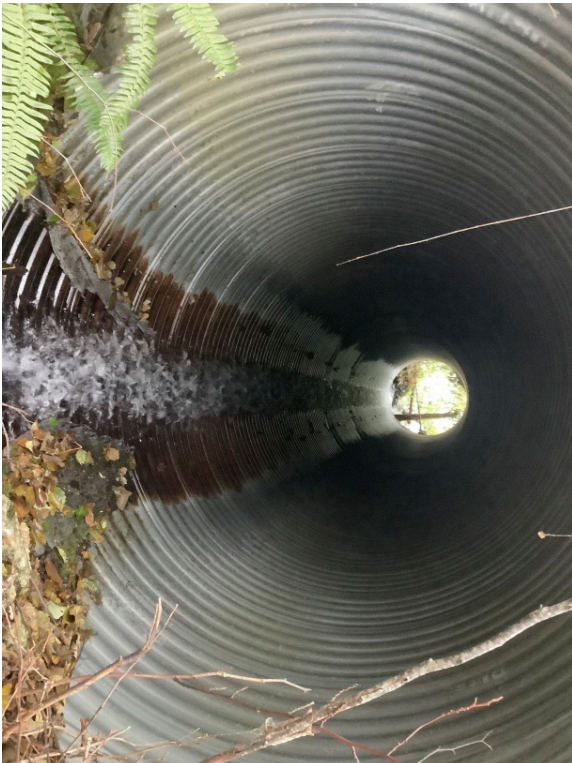
Bush side culvert

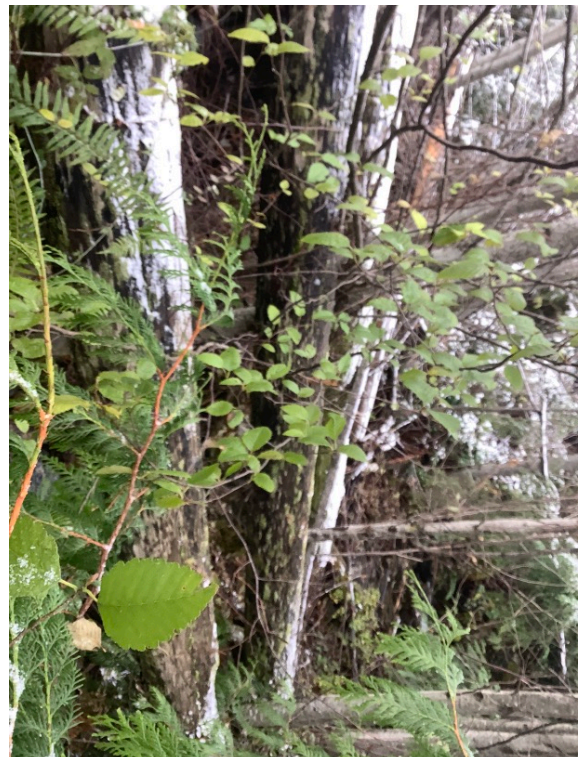
Trash rack old logs. Approx 20mm sap rot. Likely ineffective. No sign of debris movement. Stream doesn't appear to have high flows. Likely not needed

Trash Rack Poor Logs, approx. 20mm sap rot.

Log trask rack. Rotten logs

Load Rated by: Richard Mills, P.Eng. Jan 18, 2023  
Load Rating: L165 or 150 tonnes  
Next Inspection: 2025  
Comments: Monitor inlet

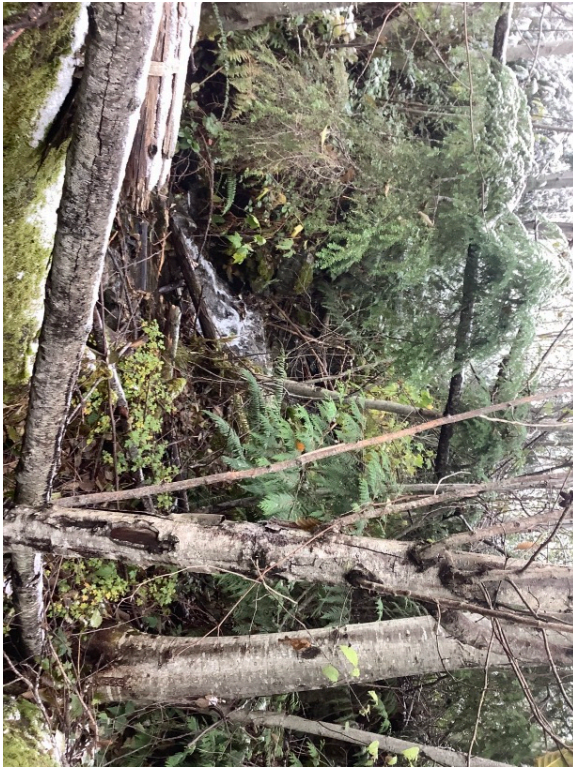
Upstream from Crossing

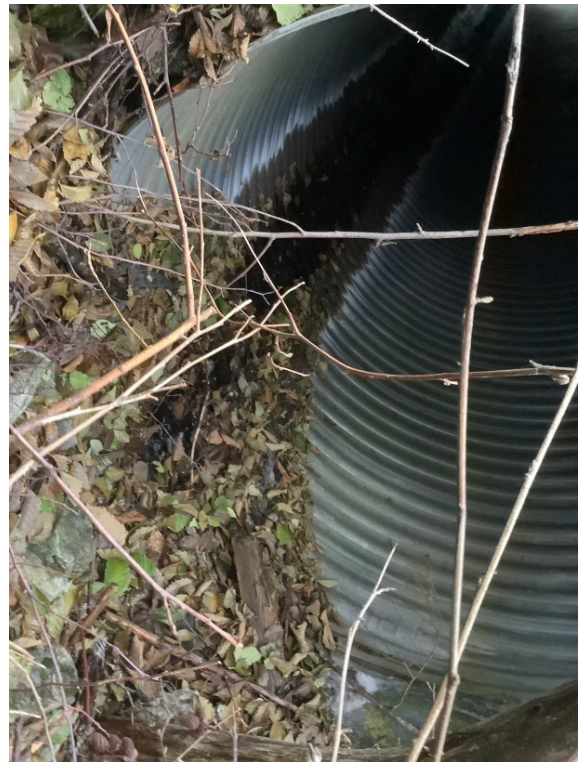
Town side culvert

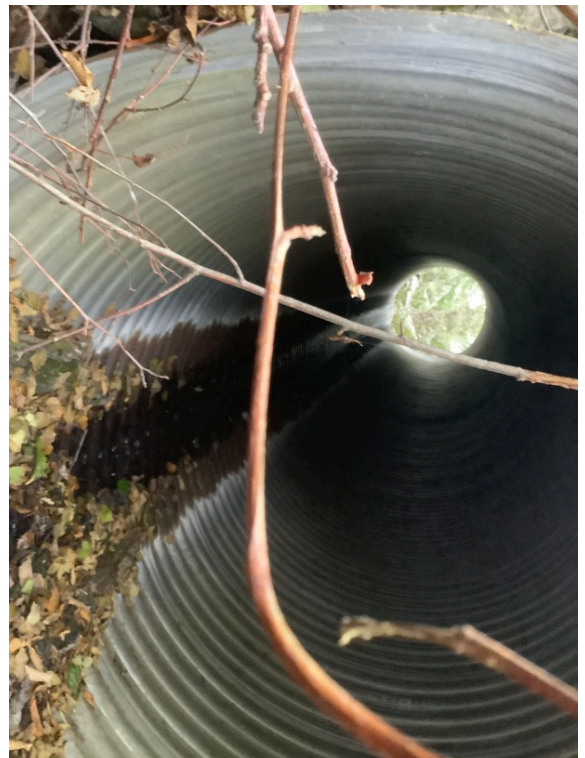
Town side culvert
