SC-8214  
SC-8214

## THEODOSIA 6.4km

2022 Inspection

Crossing Name Hernandez Creek

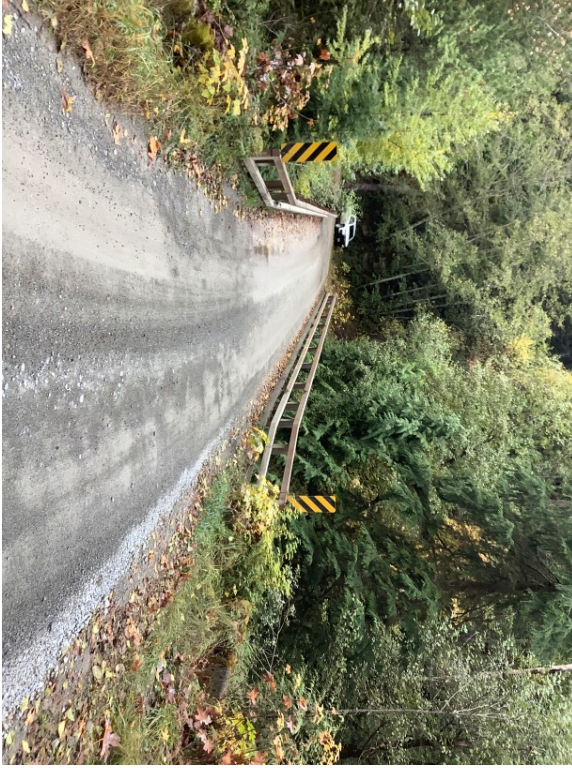
Approach from Left Bank when facing downstream

Delineator Missing  
Left ☐ 0 ☒ 1 ☐ 2

| Repair Item | Repair Description |
|---|---|
| 1 Structure. Delineator maintenance. .<br>Priority:Medium | Add delineators |

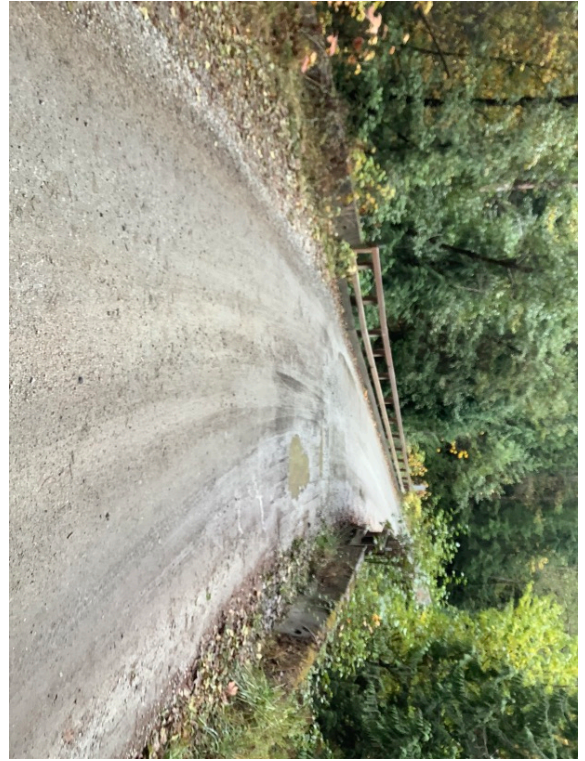
Approach from Right Bank when facing downstream

Delineator Missing  
Right ☐ 0 ☒ 1 ☐ 2

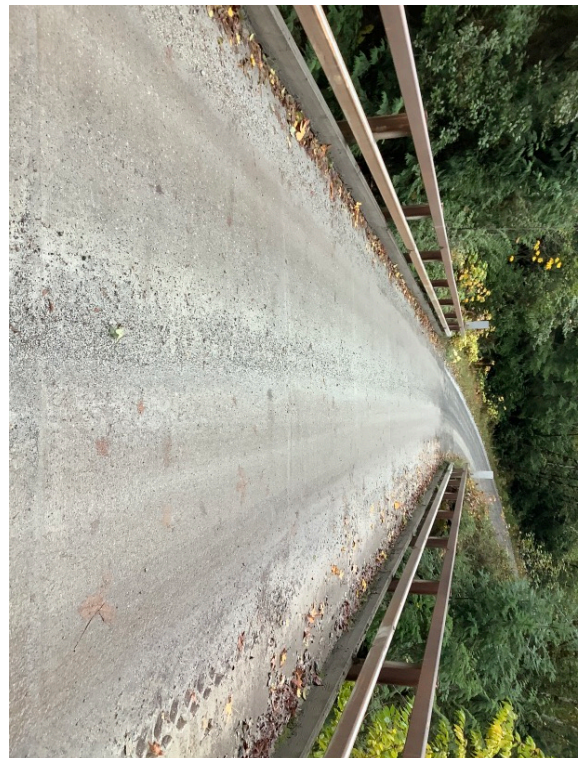
Overall Deck Condition      Good
