SC-8216  
SC-8216

THEODOSIA 7.11km

2022 Inspection

Structure Class Major Culvert

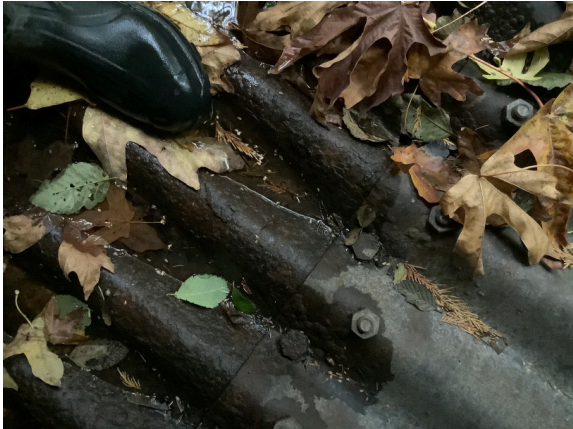
Culvert Floor

Floor      Fair      Corrosion, starting to scale

| Item | Monitor Description | Frequency |
|---|---|---|
| 1 | Monitor culvert floor for corrosion | Routine Inspection |

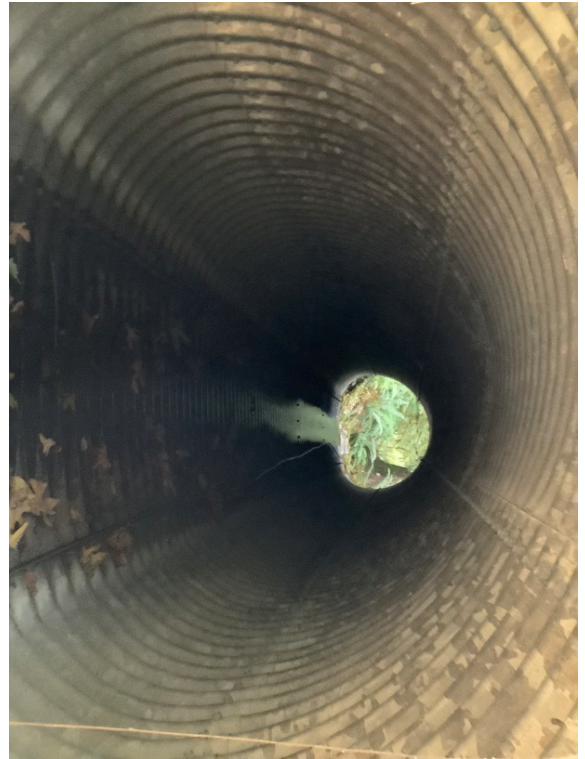
Inlet      Good

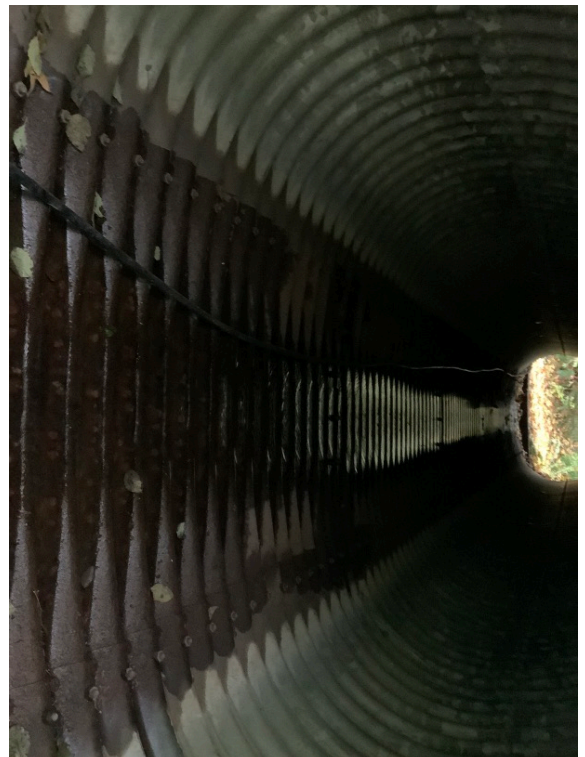
Outlet      Good
