SC-8219  
SC-8219

## THEODOSIA 11.1km

2022 Inspection

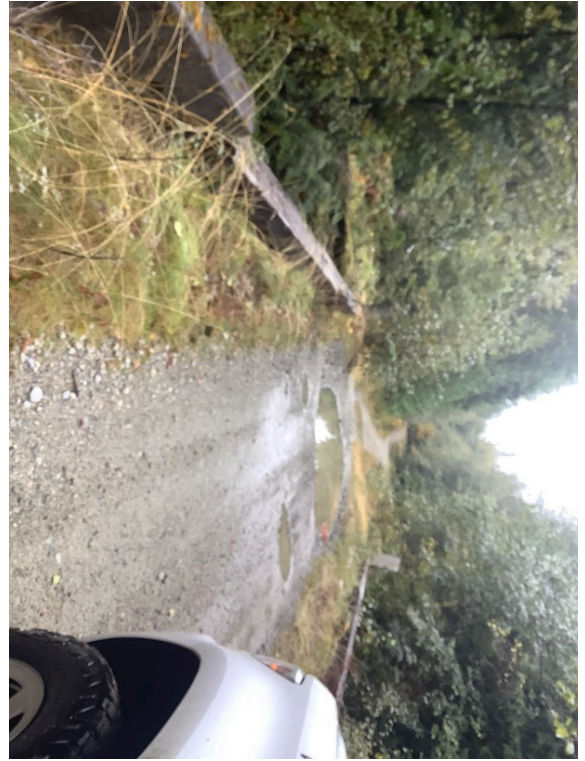
Approach from Right Bank when facing downstream

Road Surface **Fair**

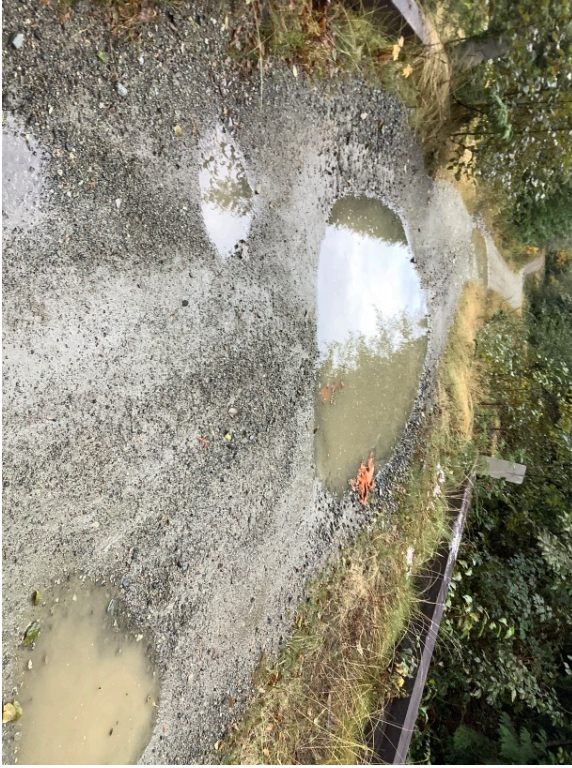
Running Surface      **Fair**

Gravel Surface      **Fair**

Overall Deck Condition      **Fair**

2 Structure. Add Fill Cover. # Add gravel to deck  
of items. Priority:Medium

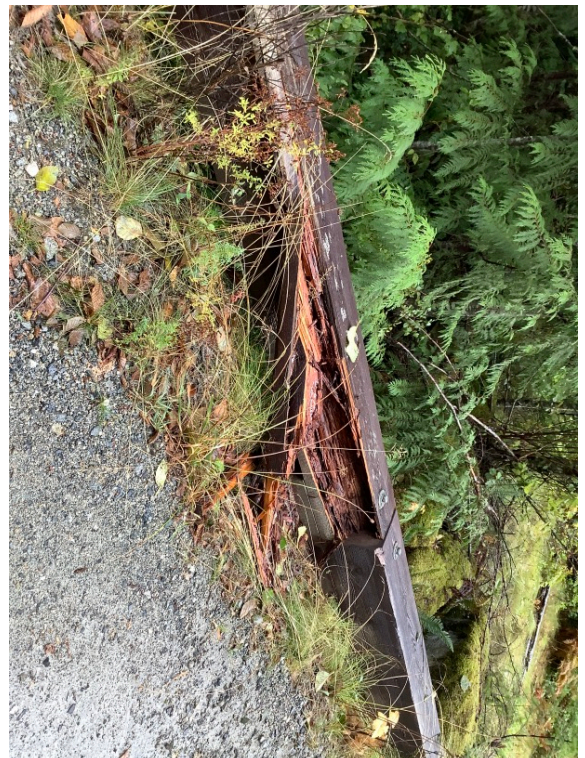
Guard Rail

Curb Rail/Blocks/Posts      **Poor**      Rotten, replace

1 Structure. Full Curb  
Replacement. . Priority:High
