SC-8225  
SC-8225

THEODOSIA 0.35km

2022 Inspection

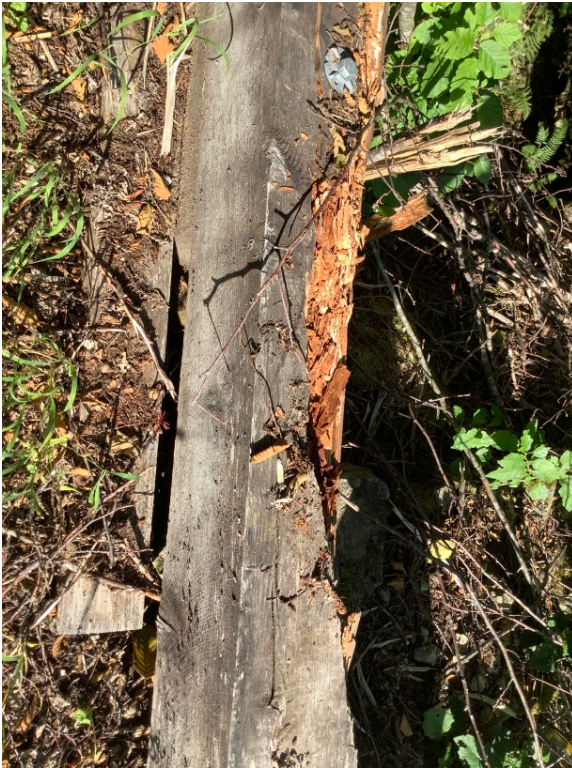
Guard Rail

Curb Rail/Blocks/Posts      Poor      Rotten

Load Rated by: Richard Mills, P.Eng. Jan 12, 2023  
Load Rating: L165 or 150 tonnes  
Next Inspection: 2025  
Comments: Replace guardrails.

| 1 | Structure. Full Curb<br>Replacement. . Priority: |
