SC-8226  
SC-8226

THEODOSIA 0.65km

2022 Inspection

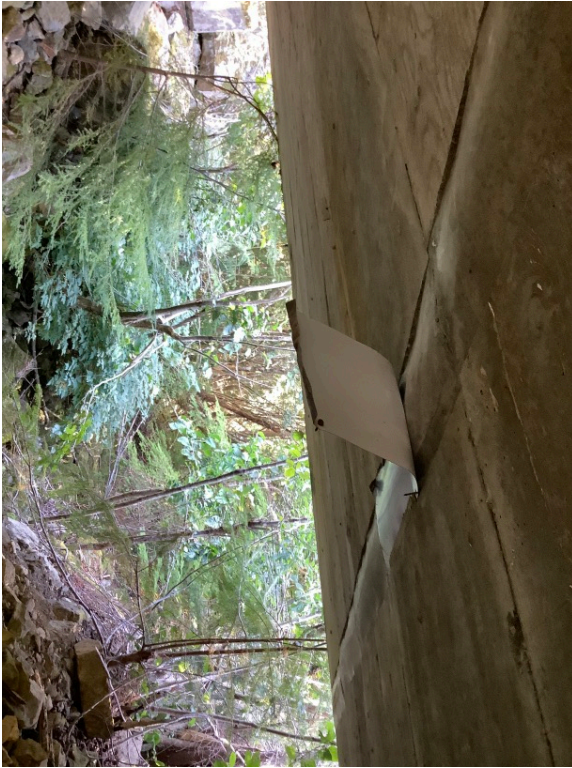
Superstructure

Girders Fair No change since last inspection

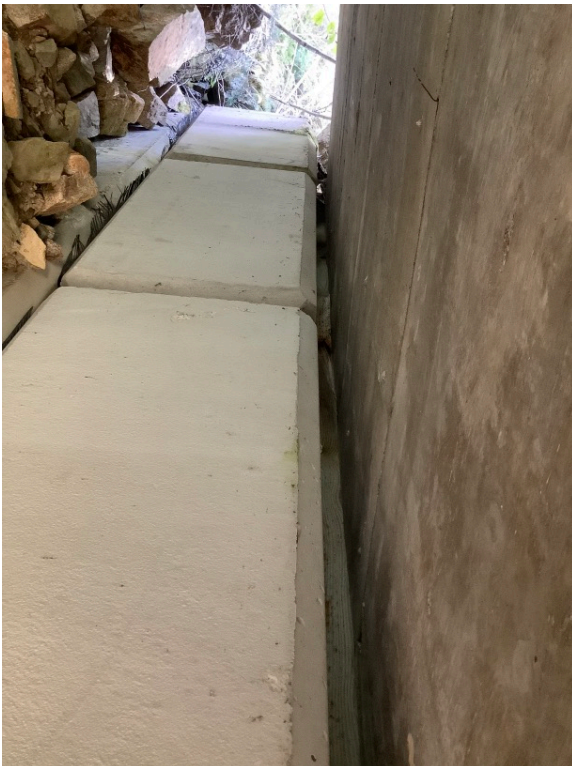
Sill right side

Caps or Sills Fair Minor crushing right side middle. Appears to be installation related. Monitor.

| Item | Monitor Description | Frequency |
|---|---|---|
| 1 | Monitor sill right side | Routine Inspection |
