SC-8227  
SC-8227

## THEODOSIA 1km

2022 Inspection

CBR iPad Offline Ver 0.34 - DSC

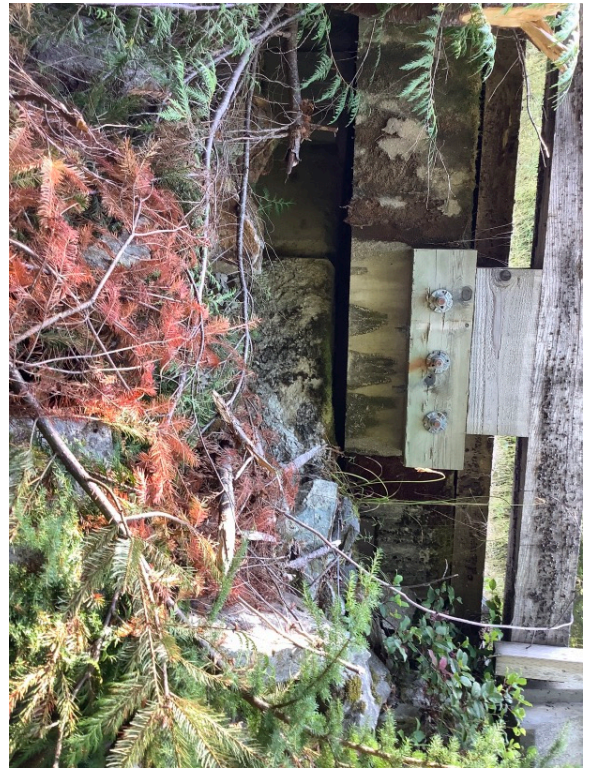
Concrete Fair Upstream right lock block spalling. All others ok

| Item | Monitor Description | Frequency |
|---|---|---|
| 1 | Monitor upstream right side lock block | Routine Inspection |
