SC-8229  
SC-8229

## THEODOSIA 1.3km

2022 Inspection

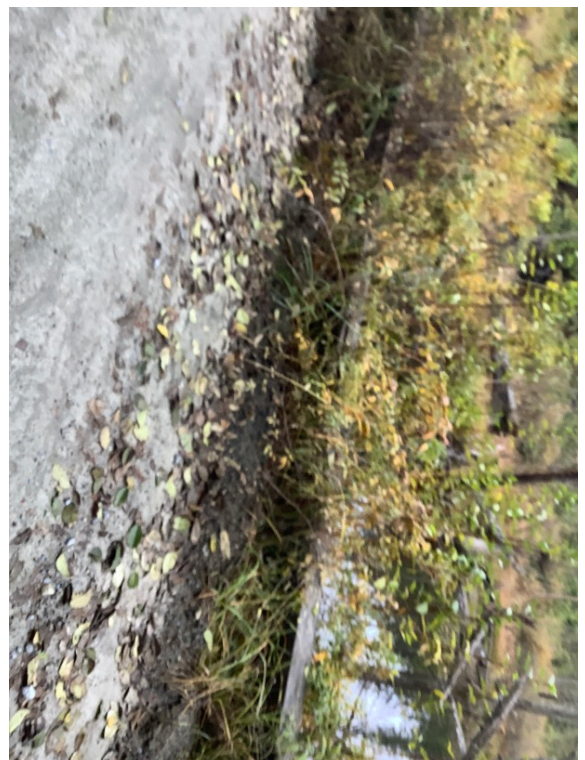
Guard Rail

Beaver dam at inlet. No apparent change since last inspection. Replace guardrails.

Curb Rail/Blocks/Posts      **Poor**      Loose, rotten. Replace.

| 1 | Structure. Full Curb Replacement. . Priority:High |
