SC-8237  
SC-8237

THEODOSIA 11.9km

2022 Inspection

Crossing Name Appleton Creek

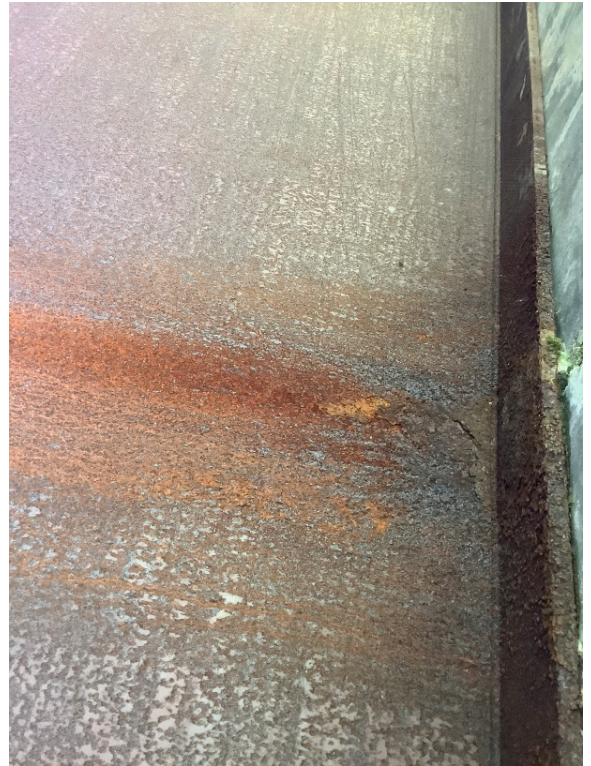
Isolated corrosion on girder, at deck joints. Upstream right side, 1st joint is worst.

Girders Fair Isolated corrosion at deck joints.

1st joint, upstream right

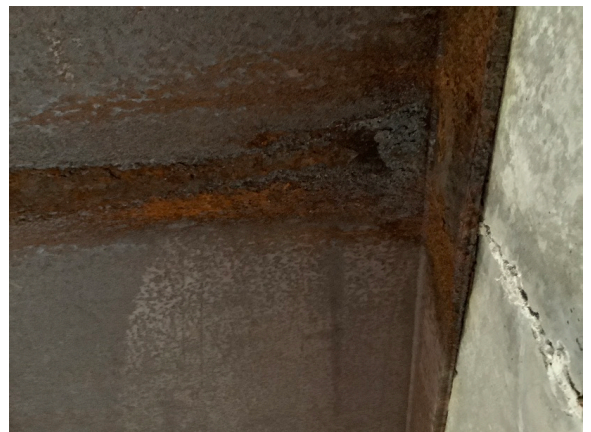
1st joint , upstream right, on inside

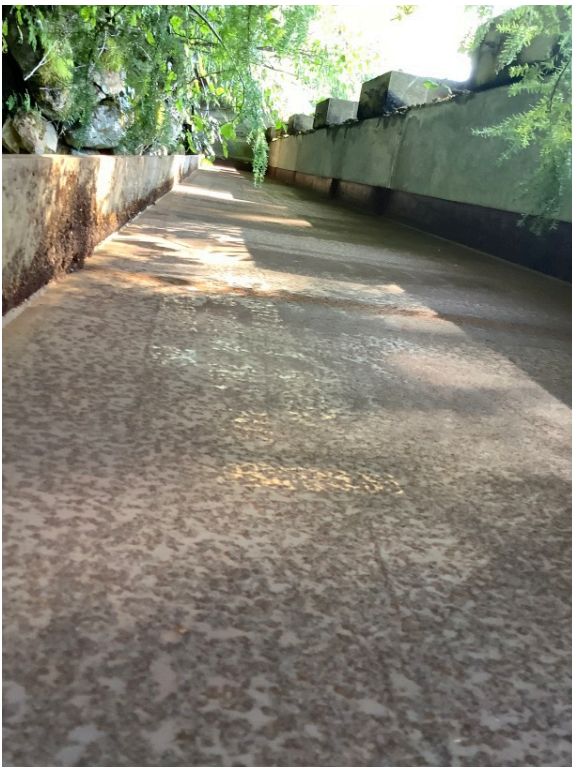
1st joint, upstream right side
