## ROBERTS FLUME 2.4km

2022 Inspection

Crossing Name Upper Clack Creek

Structure Class Temporary Bridge

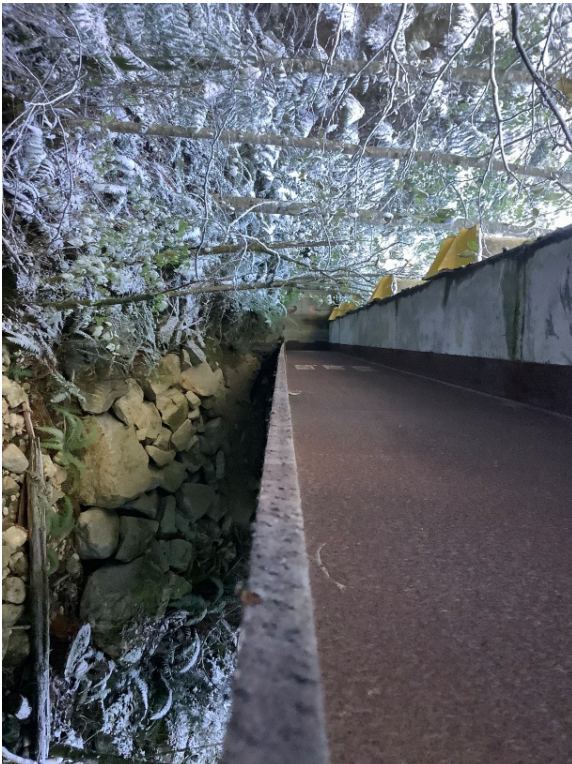
Superstructure

Girders have slight negative camber. Estimated 10mm at centre. Equal on both sides. No signs of movement. Likley ok, but should be monitored.

Girders Fair

| Item | Monitor Description | Frequency |
|---|---|---|
| 1 | Monitor girders | Routine Inspection |
