SC-8311  
SC-8311

LOIS 17.54km

2022 Inspection

Crossing Name Scanlon

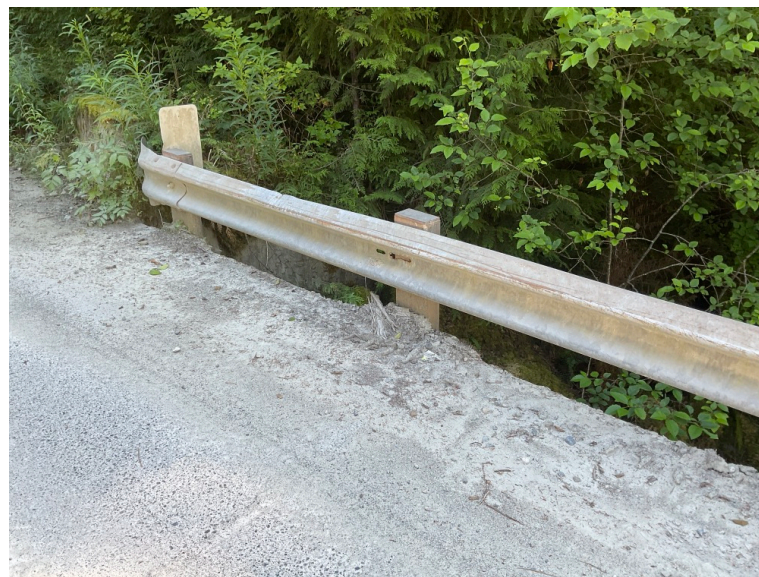
Guard Rail

Curb Rail/Blocks/Posts Fair Upstream right bank riser is missing a bolt

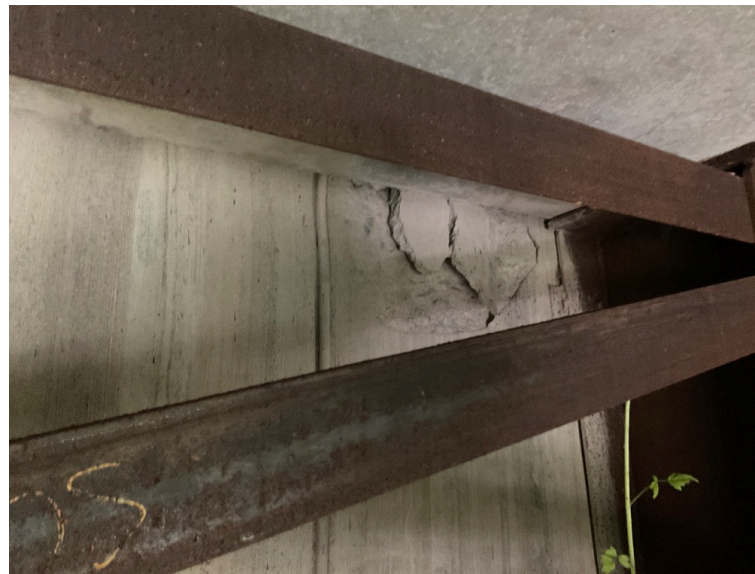
Ballast Wall Fair Left bank wall is spalling

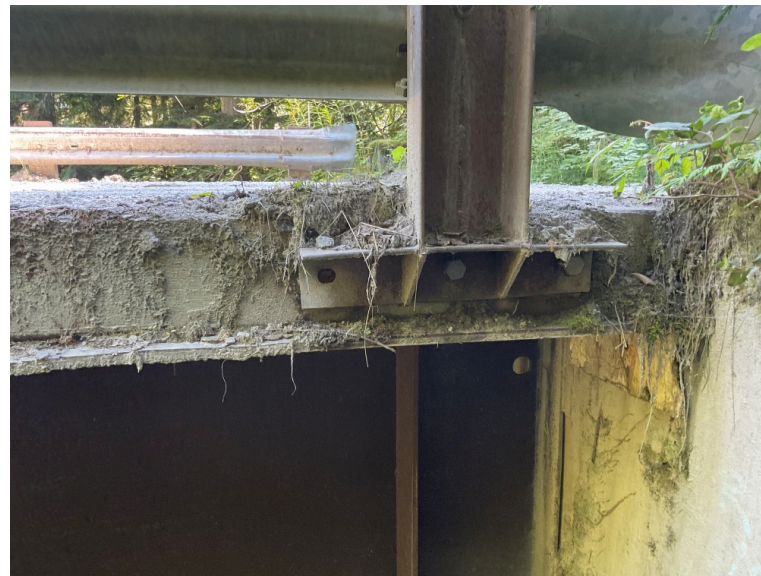
Guard Rail

Hardware Fair Upstream right bank riser is missing a bolt
