SC-8313  
SC-8313

TEXADA ISLAND 0.3km

2022 Inspection

Crossing Name Bob's Lake outlet

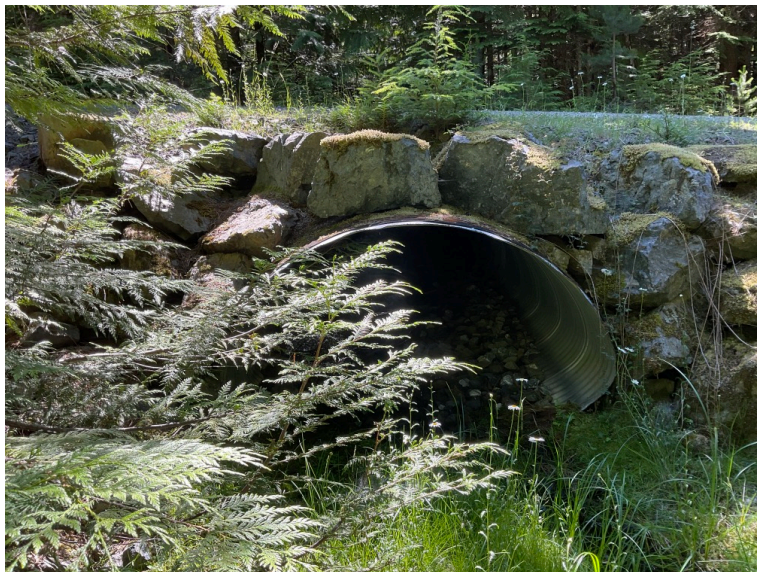
Inlet Fair

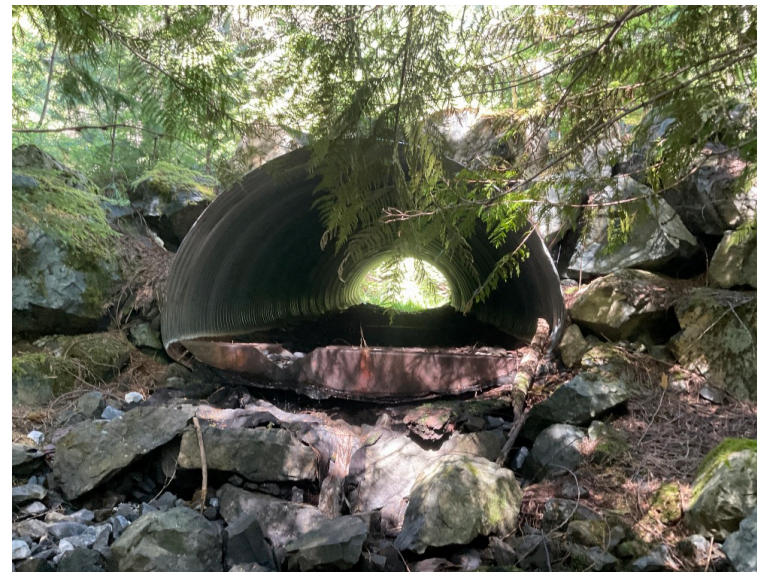
Outlet Fair

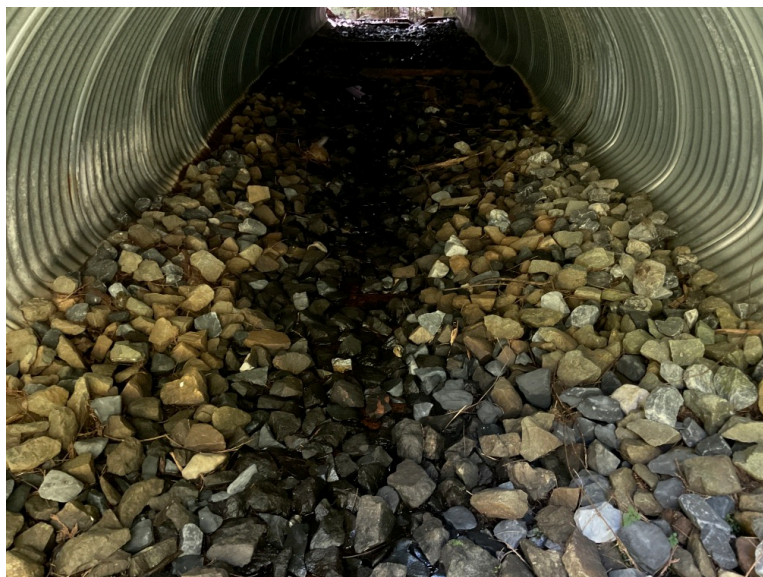
Culvert Floor

Floor Fair
