SC-8314  
SC-8314

TEXADA ISLAND 0.55km

2022 Inspection

Crossing Name Mouat Creek

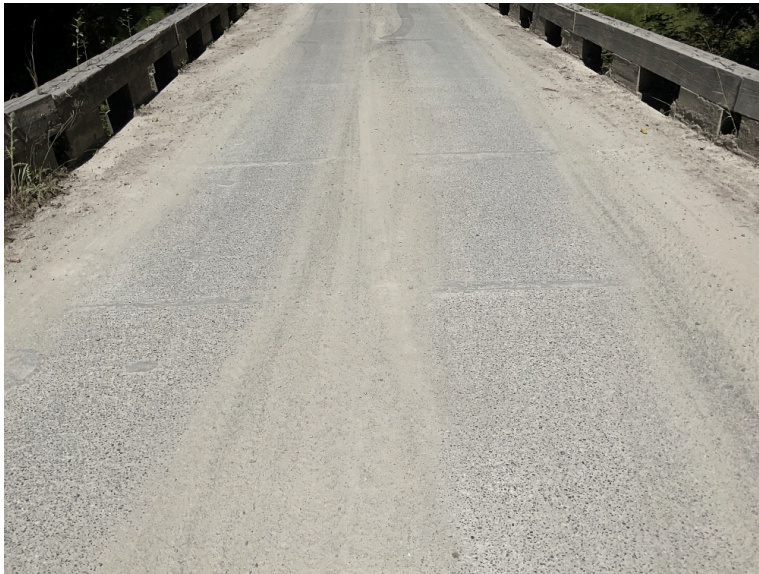
Overall Deck Condition Fair

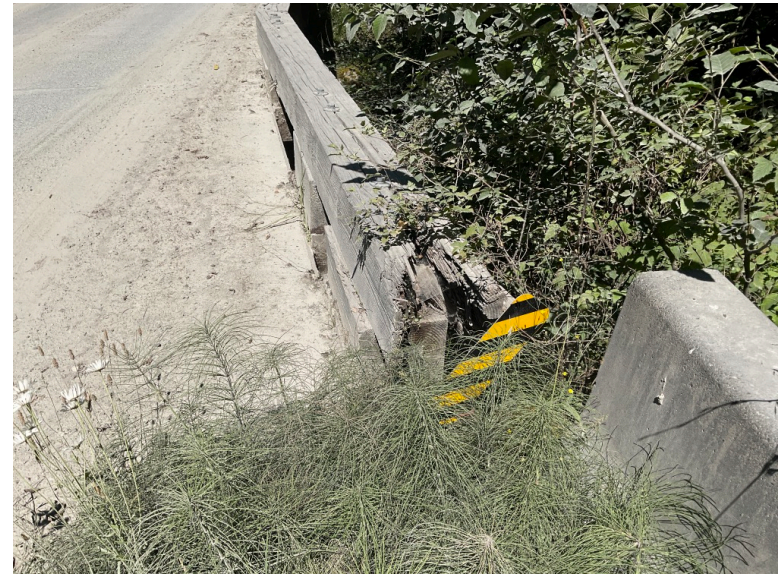
Guard Rail

Curb Rail/Blocks/Posts Poor Rotten

| Repair Item | Repair Description |
|---|---|
| 1 Structure. Full Curb Replacement. 1 . Priority:High | Replace all guardrails. It is recommended that HSS is used |

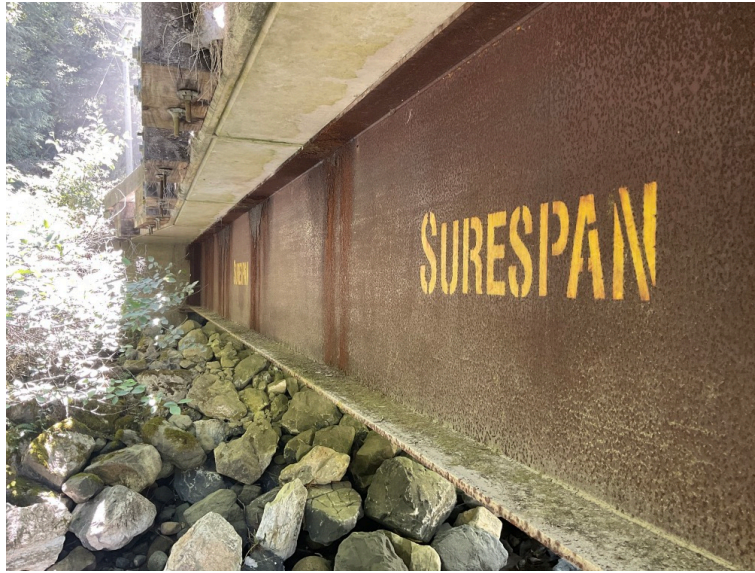
Superstructure

Corrosion at deck joints
