SC-8315  
SC-8315

TEXADA ISLAND 4.99km

2022 Inspection

Structure Class Major Culvert

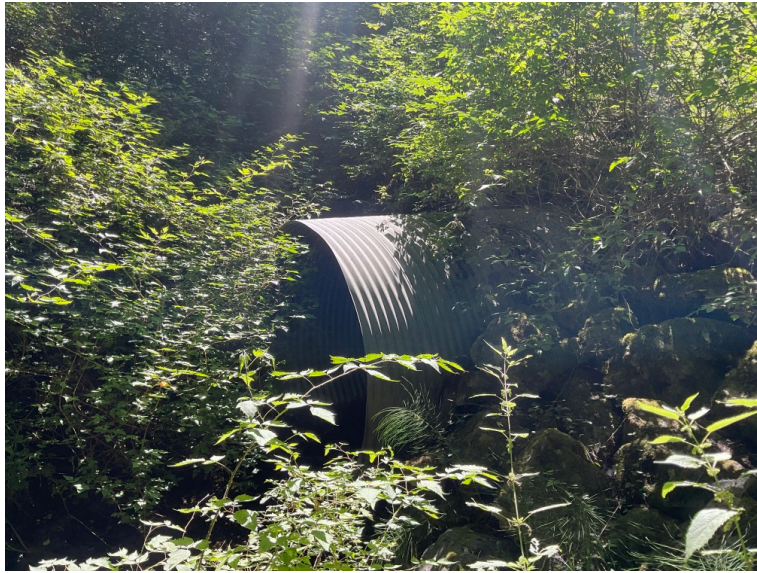
Inlet Fair

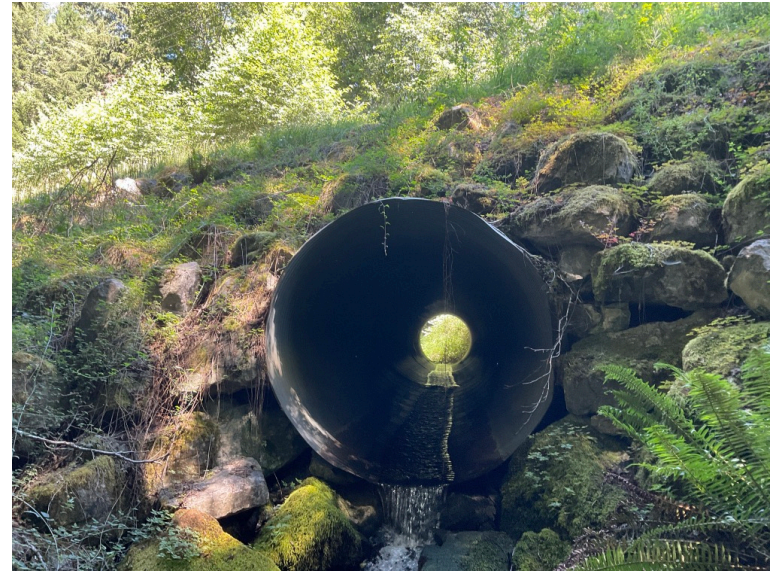
Outlet Fair

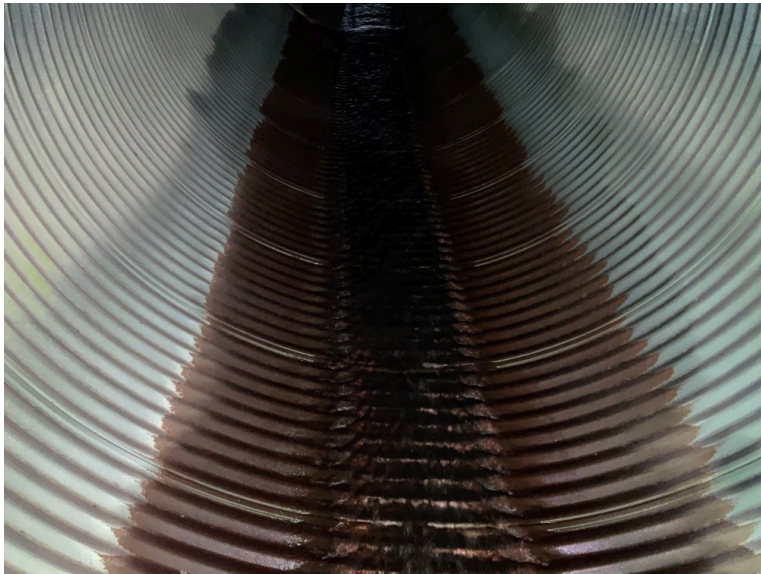
Culvert Floor

Floor Fair Minor corrosion
