SC-8316  
SC-8316

TEXADA ISLAND 6.65km

2022 Inspection

Structure Class Major Culvert

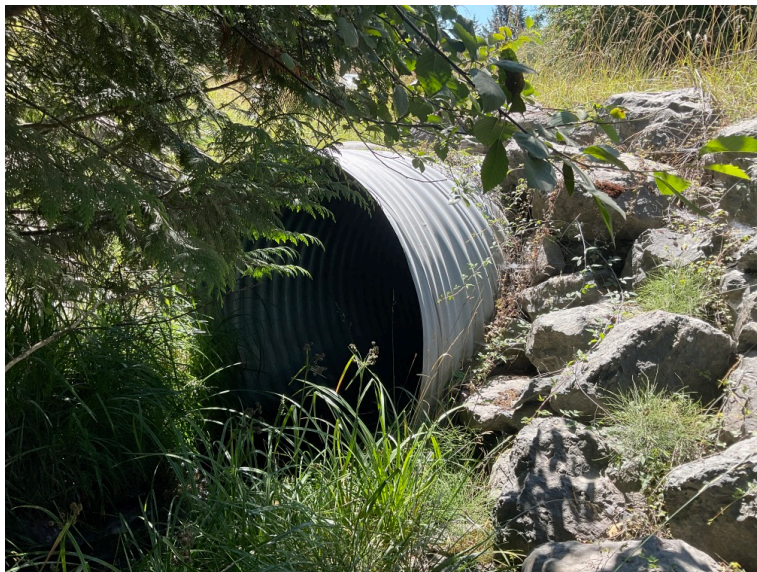
Inlet Fair

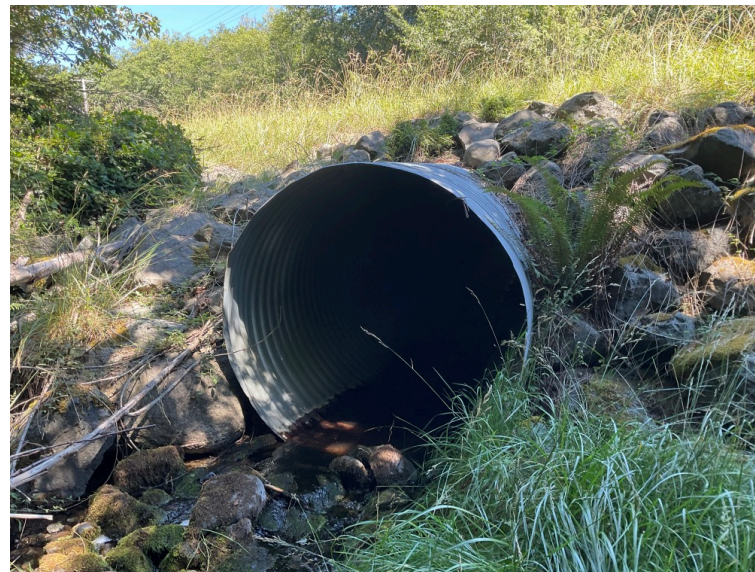
Outlet Fair

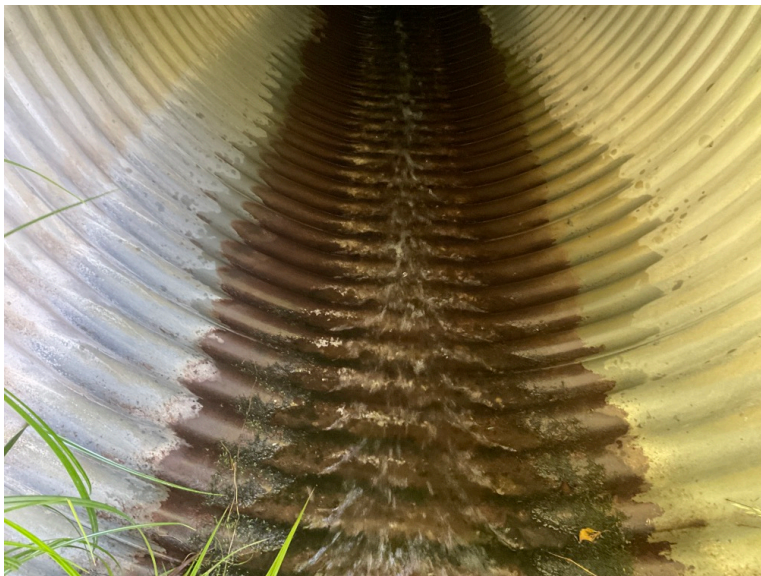
Culvert Floor

Floor Fair Minor corrosion
