SC-8317  
SC-8317

## TEXADA ISLAND 2.25km

2022 Inspection

Structure Class Major Culvert

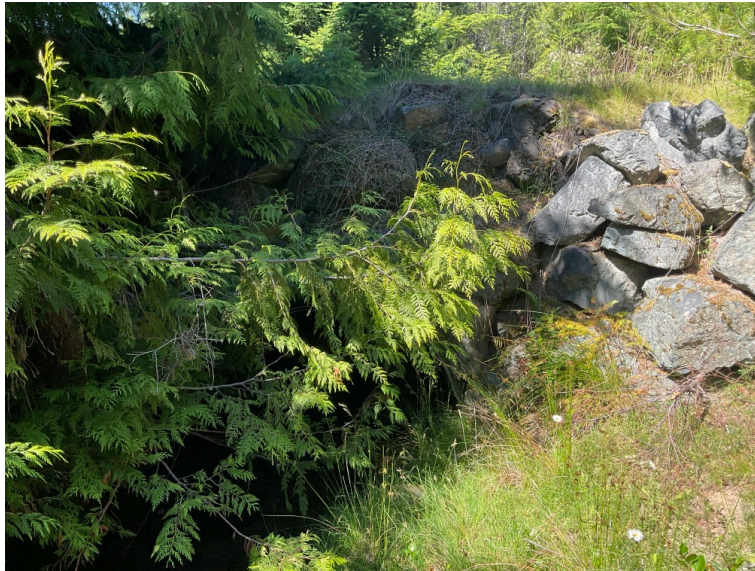
Inlet Fair

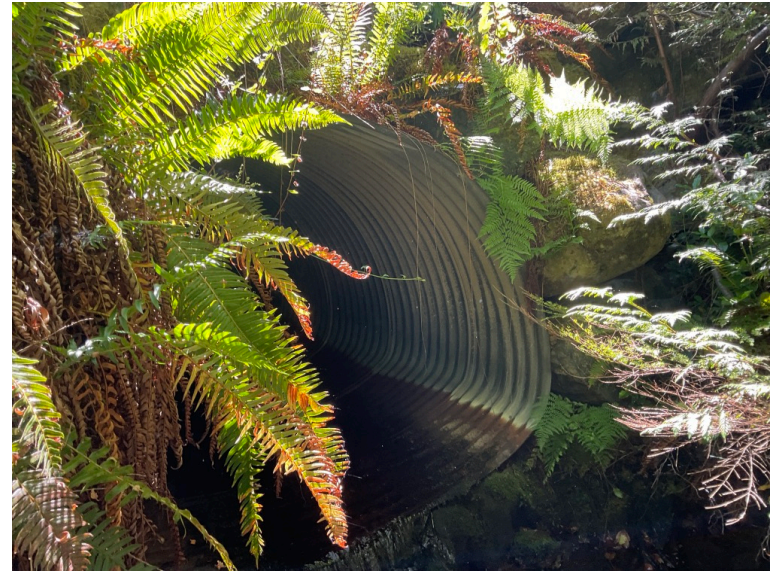
Outlet Fair

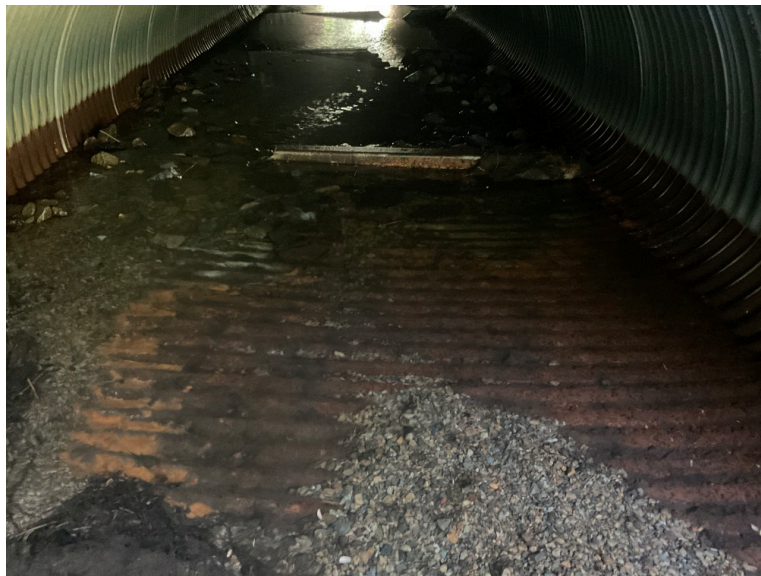
Culvert Floor

Floor Fair Minor corrosion
