SC-8318  
SC-8318

TEXADA ISLAND 0.02km

2022 Inspection

Structure Class Major Culvert

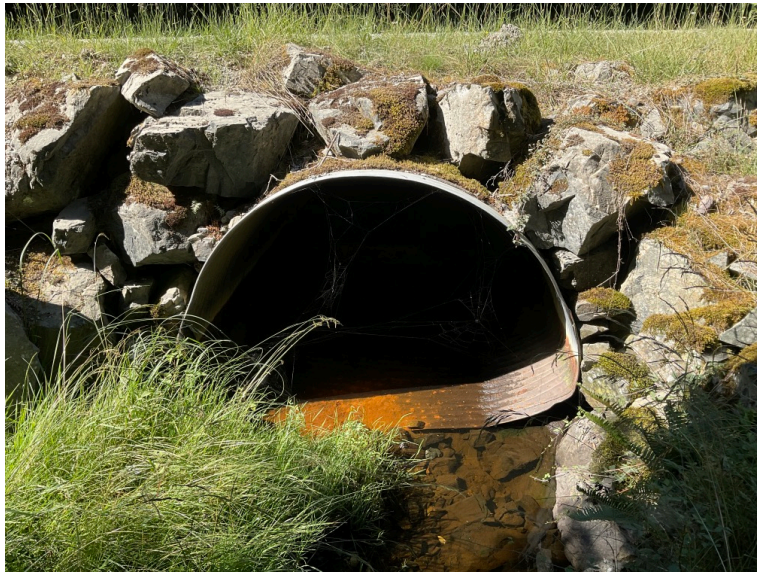
Inlet Fair

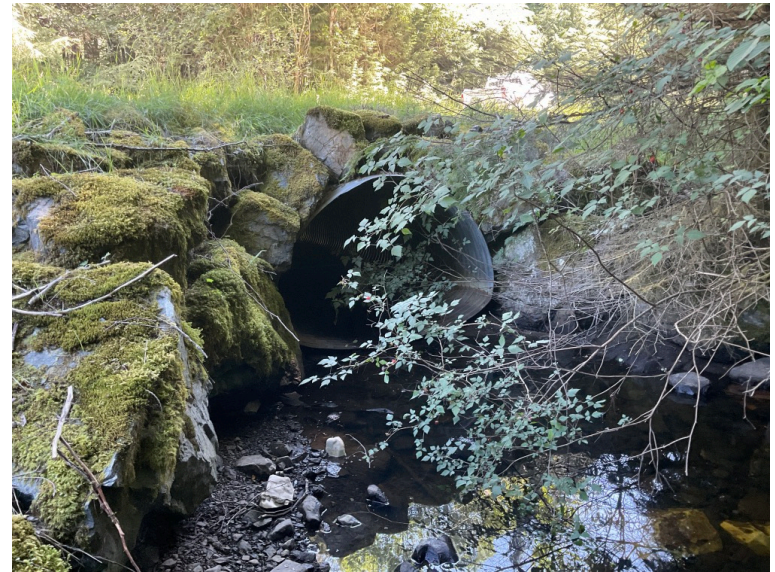
Outlet Fair

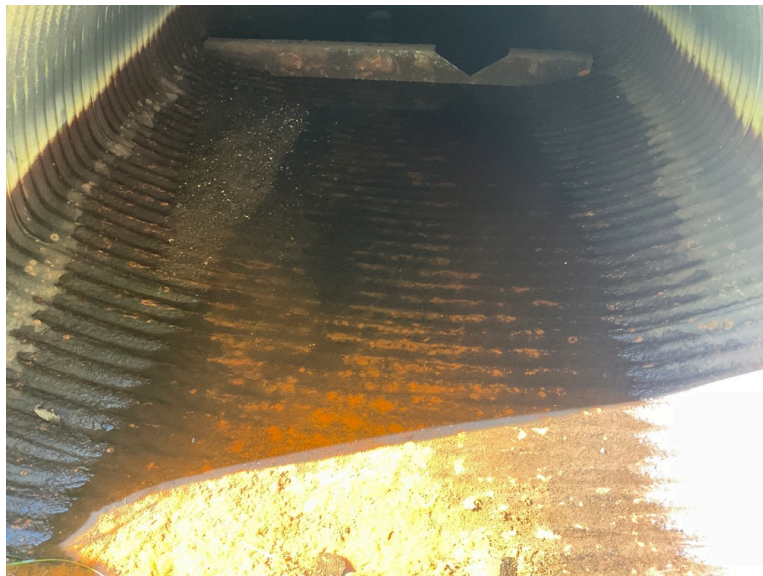
Culvert Floor

Floor Fair Moderate corrosion

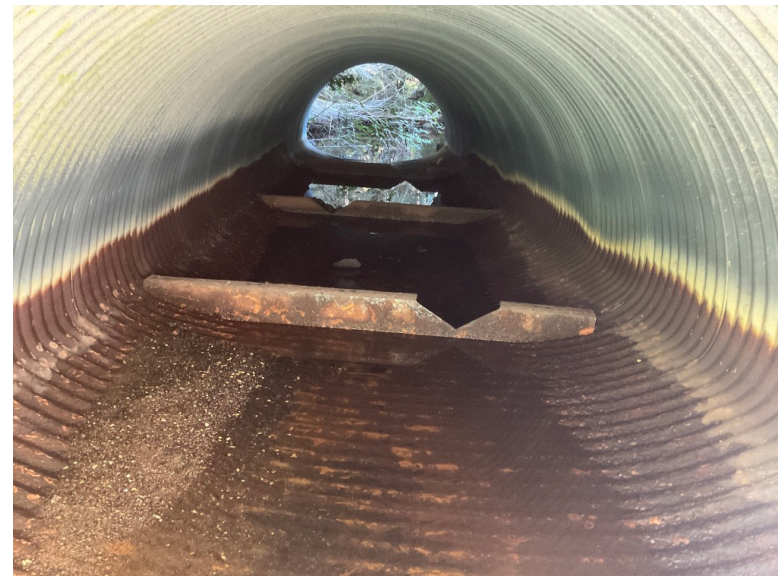
Looking Downstream Through CMP

Embedment Materials Poor All material has been flushed out of CMP
