SC-8320  
SC-8320

TEXADA ISLAND 0.5km

2022 Inspection

Structure Class Major Culvert

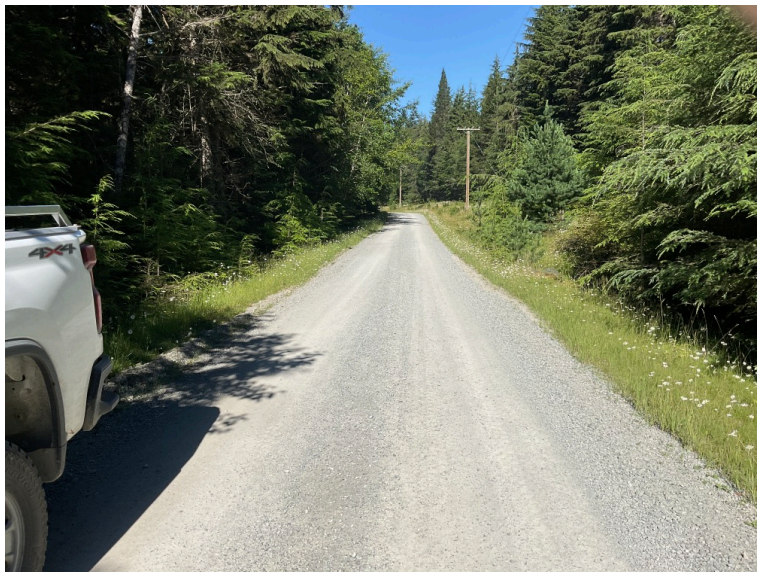
Approach from Left Bank when facing downstream

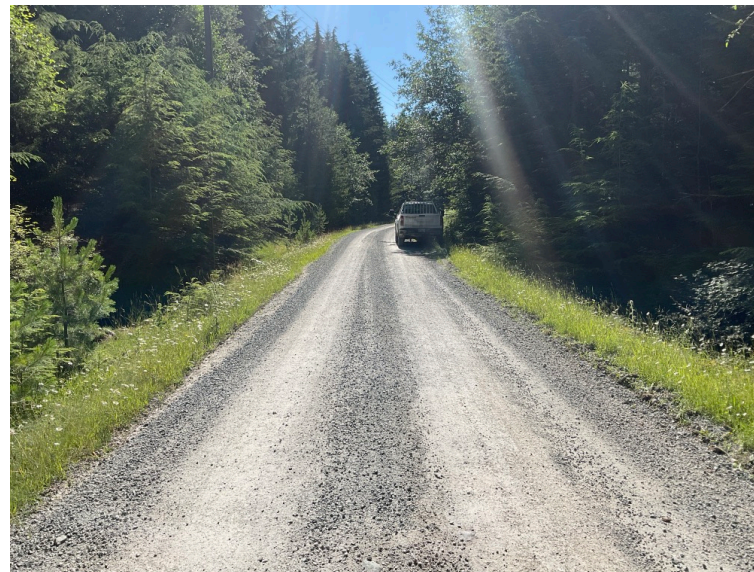
Approach from Right Bank when facing downstream

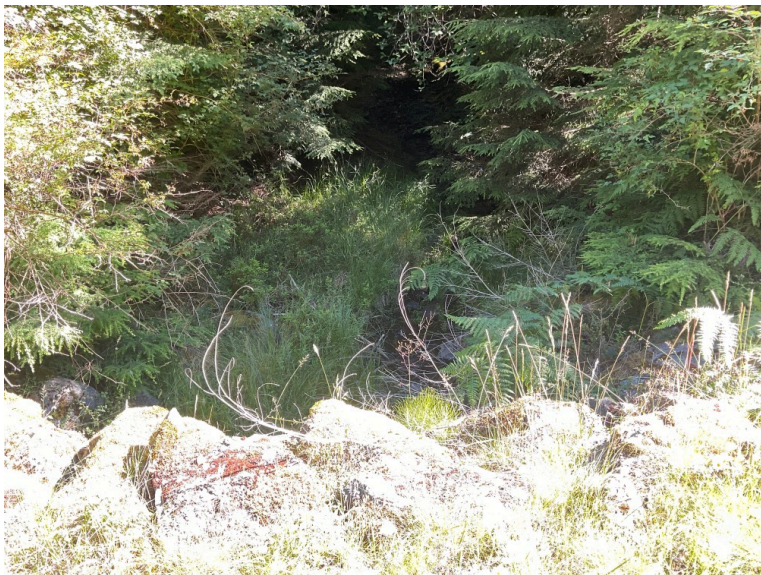
Upstream from Crossing

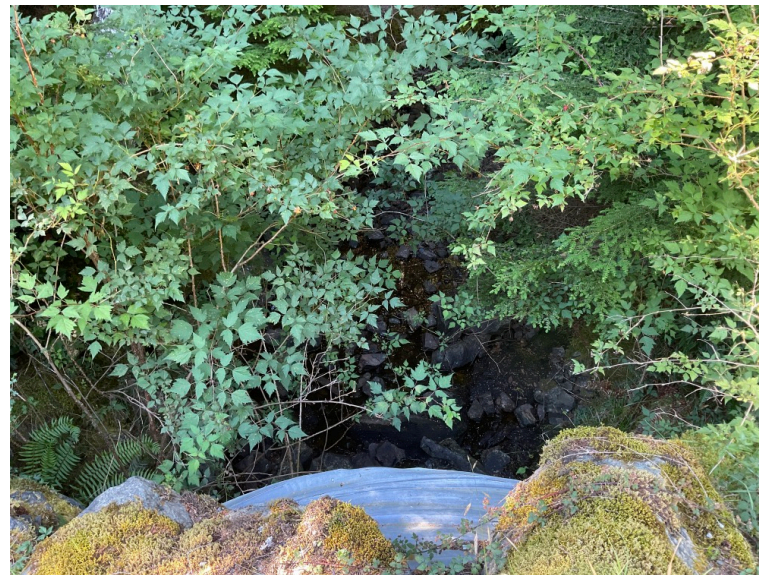
Embedment Materials Poor Downstream section is washed out

Downstream from Crossing

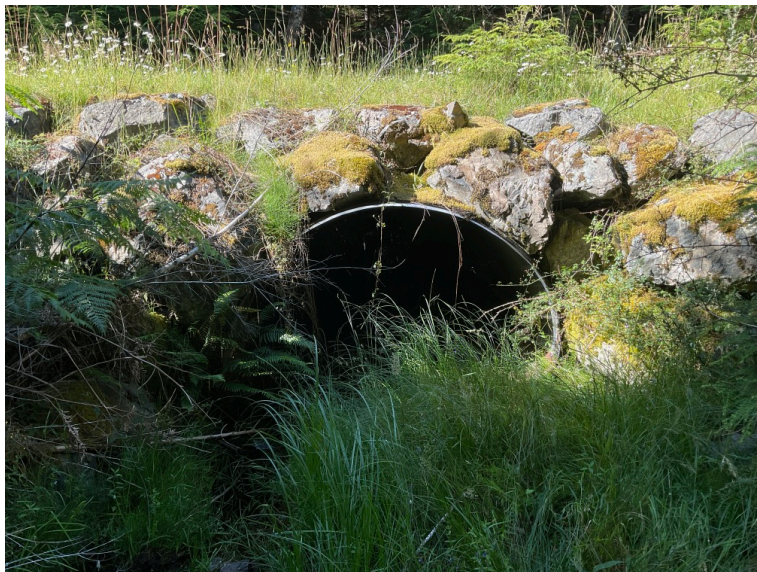
Inlet Fair

Inlet

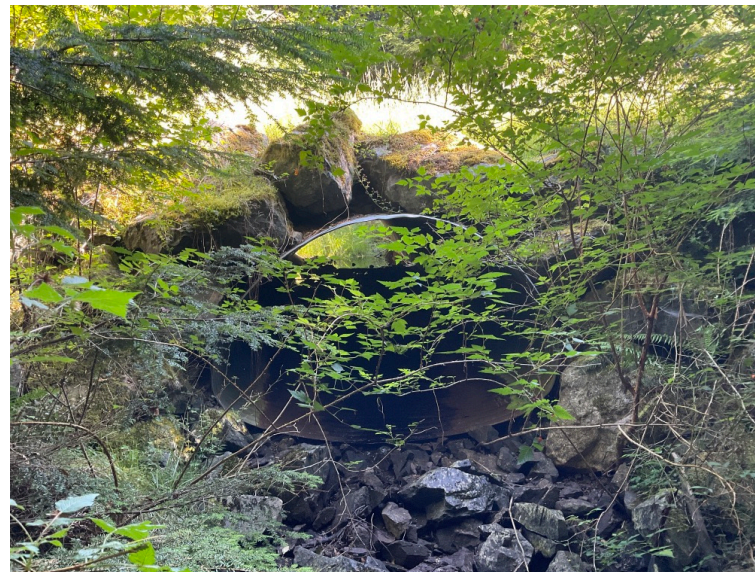
Outlet Fair

Outlet

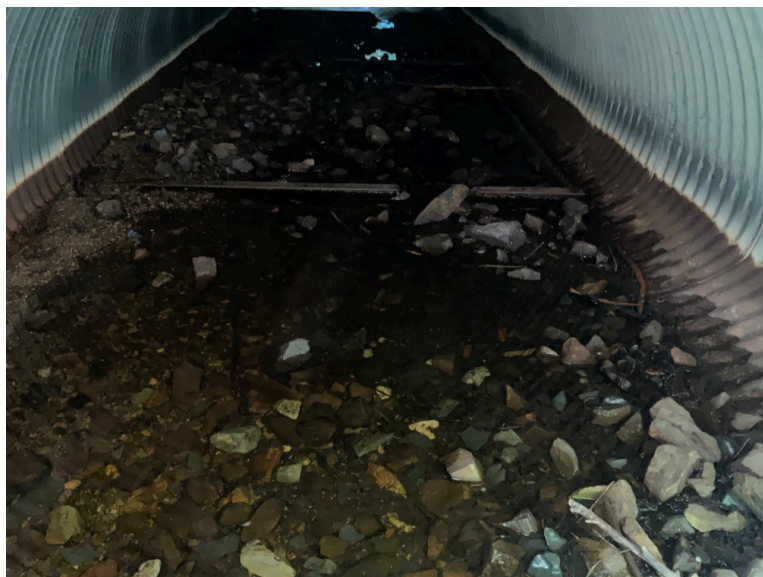
Floor Fair Moderate corrosion

Culvert Floor

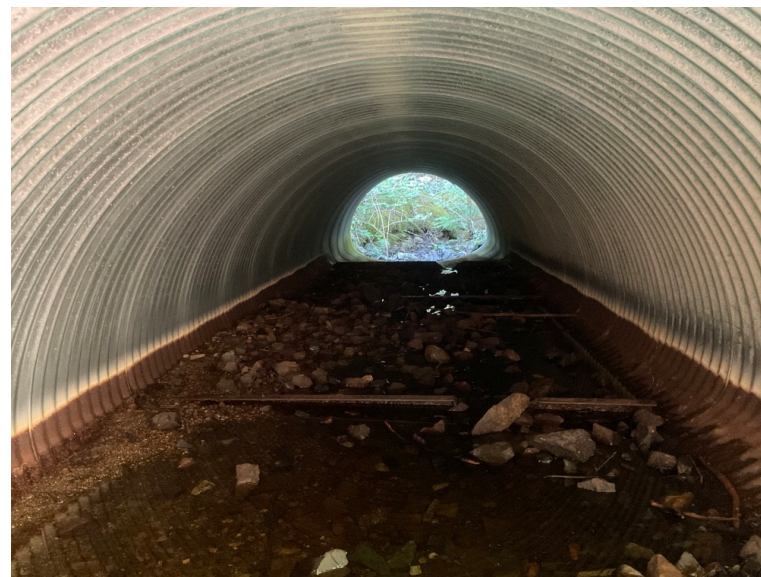
Looking Downstream Through CMP
