SC-8321  
SC-8321

TEXADA ISLAND 4.75km

2022 Inspection

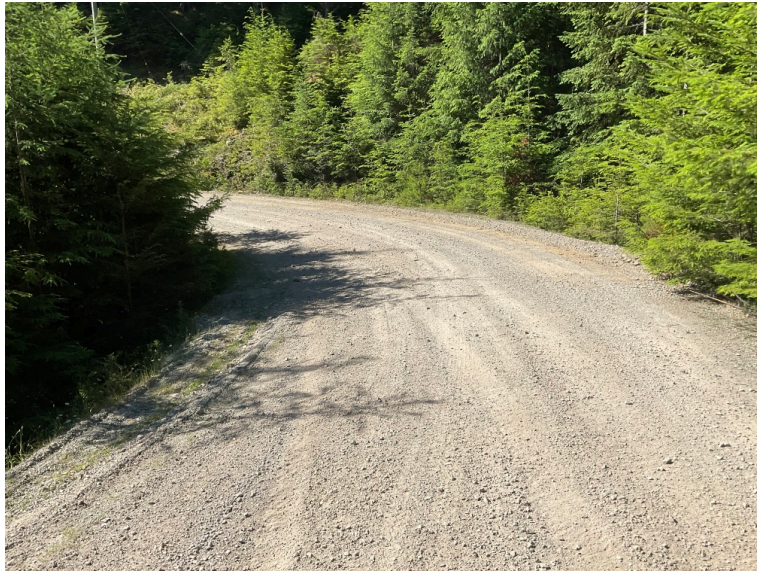
Approach from Left Bank when facing downstream

Tight corner with soft Downstream shoulder

| Repair Item | Repair Description |
|---|---|
| 1 | Approach. Reconstruct fill. 10 m³. Priority:Low |

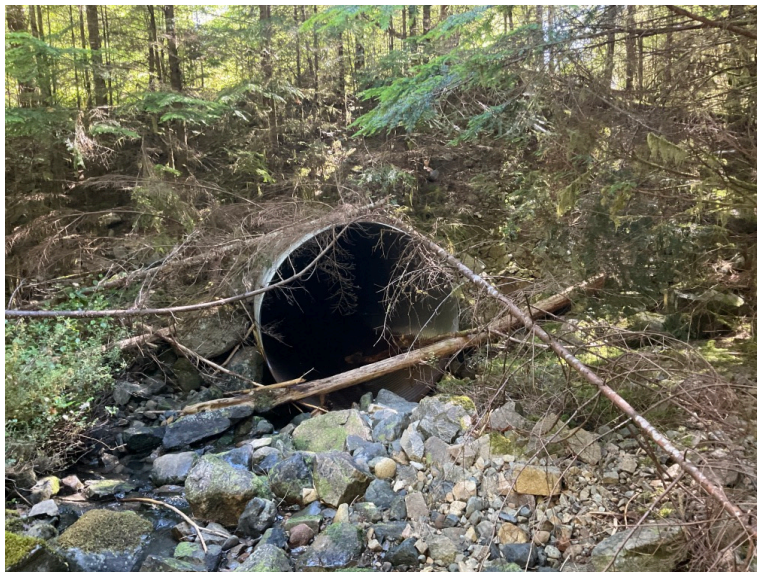
Inlet Fair

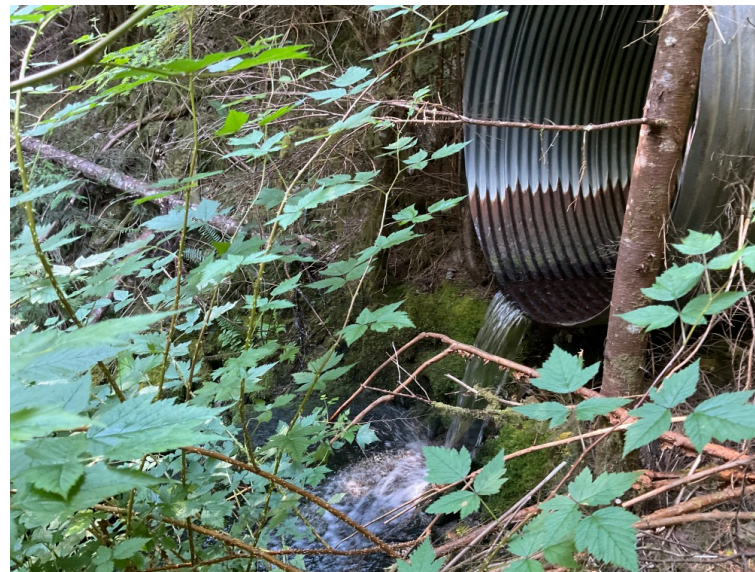
Outlet Fair Plunge of 1m down to large slimy boulder

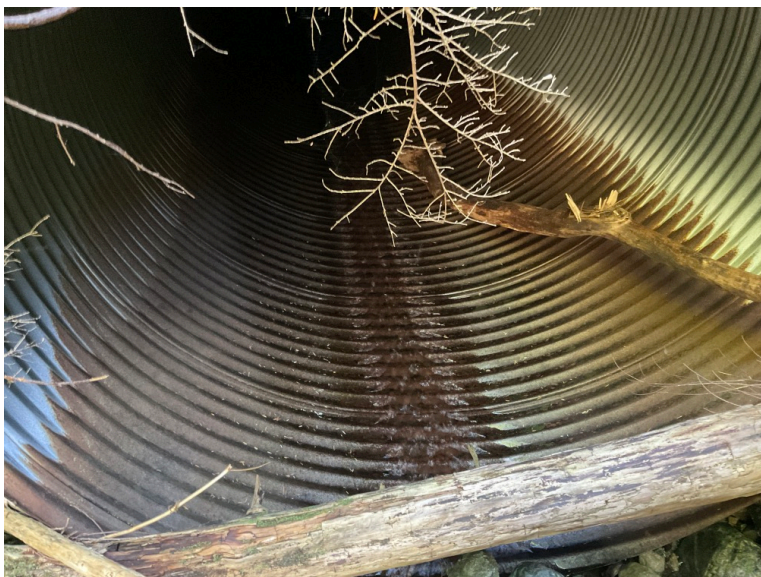
Culvert Floor

Coupled Connections Poor All couplers are corroded through on the floor

Floor Fair Minor corrosion

| Item | Monitor Description | Frequency |
|---|---|---|
| 1 | Monitor culvert couplers for separation | Routine Inspection |
