SC-8322  
SC-8322

## TEXADA ISLAND 4.8km

2022 Inspection

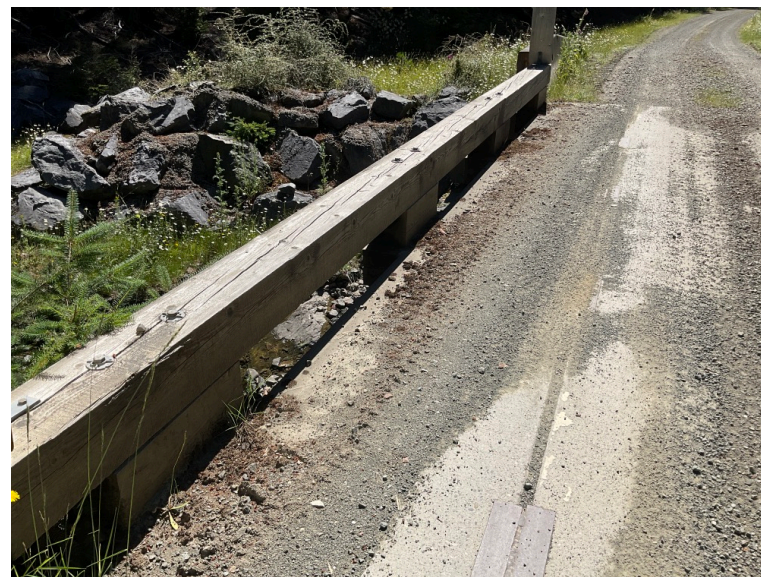
Guard Rail

Approximately 4 years of life left in timber guard rails
