SC-8347  
SC-8347B

BRITAIN RIVER 0.24km

2022 Inspection

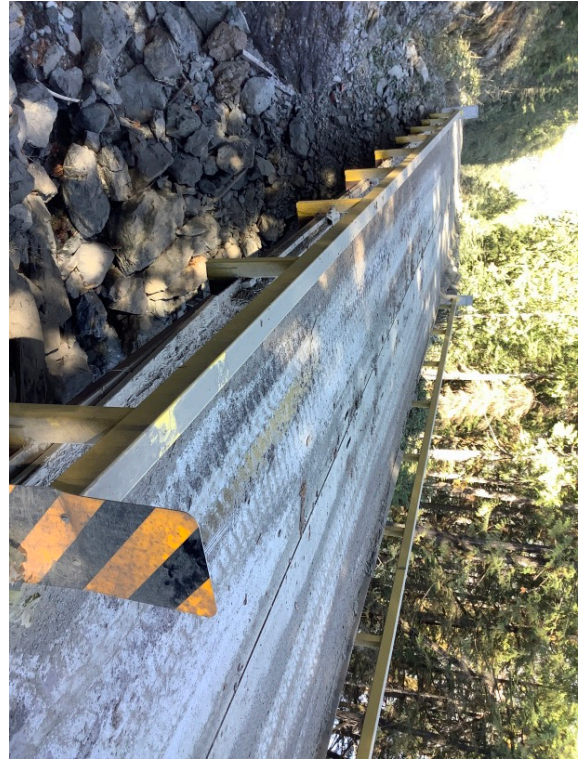
Upstream Profile

Fender Condition **Fair** Missing on us left, small on us right

| Repair Item | Repair Description |
|---|---|
| 1 Approach. Approach fenders (install). # of units.<br>Priority:Low | Add approach logs us side |
