SC-8356  
SC-8356

BEAVER 3.9km

2022 Inspection

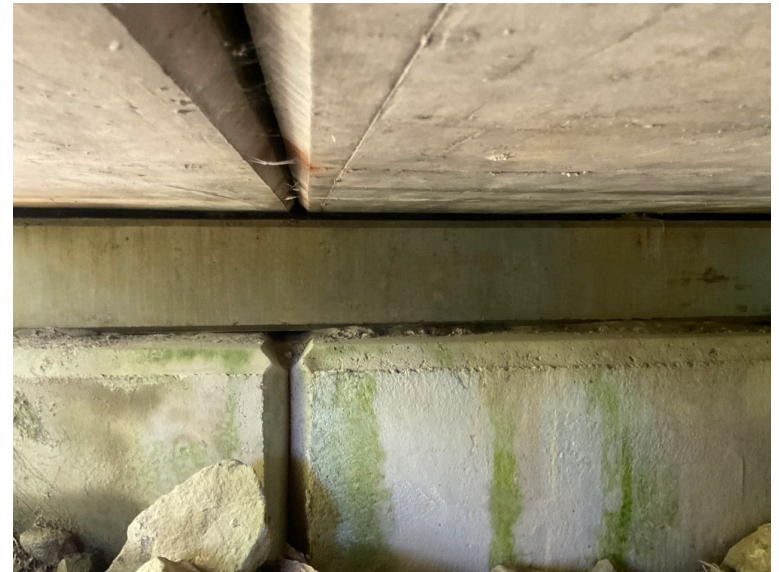
Bearing

Bearings Fair
