SC-8358  
SC-8358

## SECHELT CREEK 8.03km

2022 Inspection

Structure Class Temporary Bridge

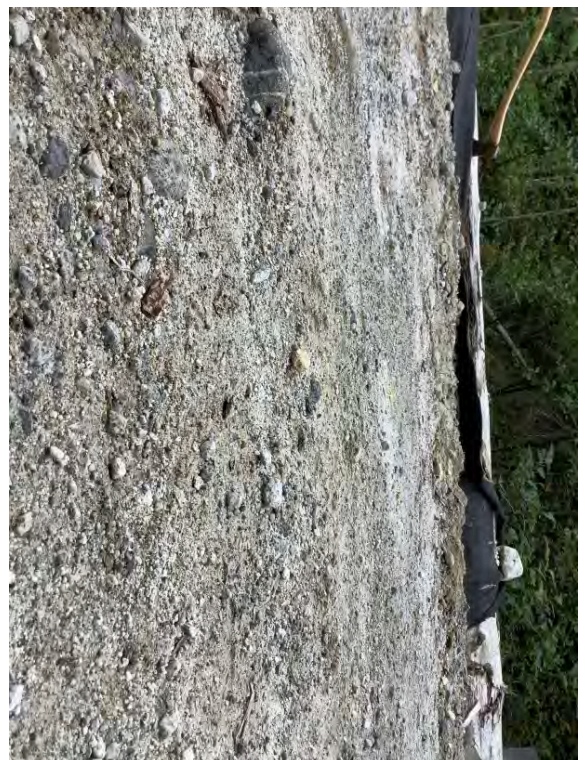
Guard Rail

Curb Rail/Blocks/Posts      Poor      Logs, less than 10" above deck on upstream side

Comments: New stringers installed over existing bridge in 2021. Stringers were not inspected due to being buried. Load rating based on information provided in "Sechelt Creek Main Overlay Construction Certification 8+027 and 8+087" sealed June 18, 2021. Post load rating and advise road users. Increase curb height on upstream side.

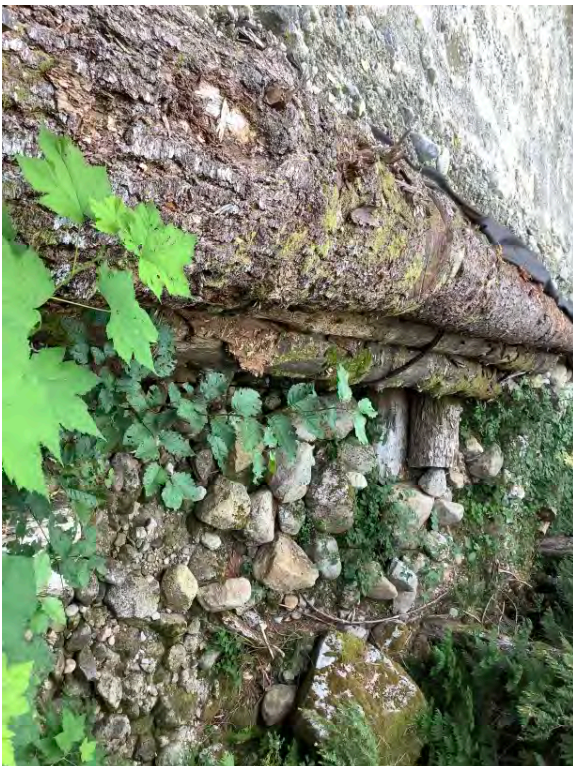
Most stringers have konk

Downstream Profile - note conk in outside stringer

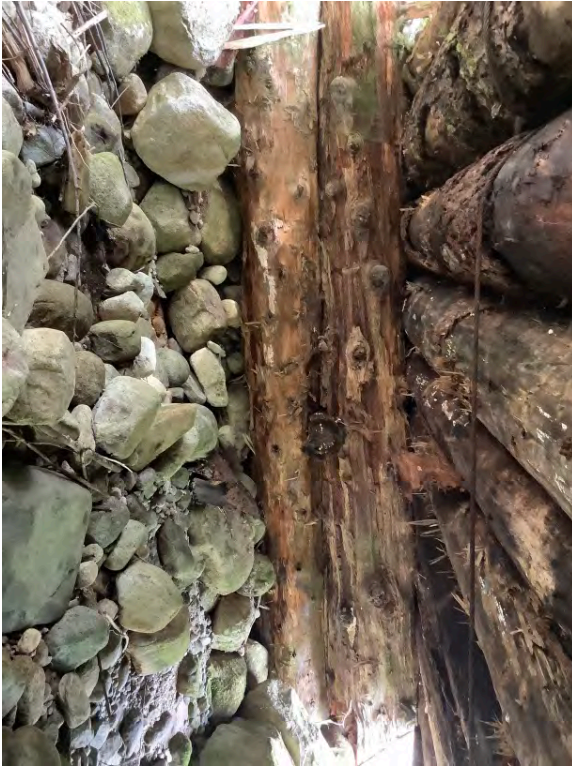
Right Bank Abutment when facing downstream

Log/Timber Cribs **Fair** Poorly supported (scoured), rot present

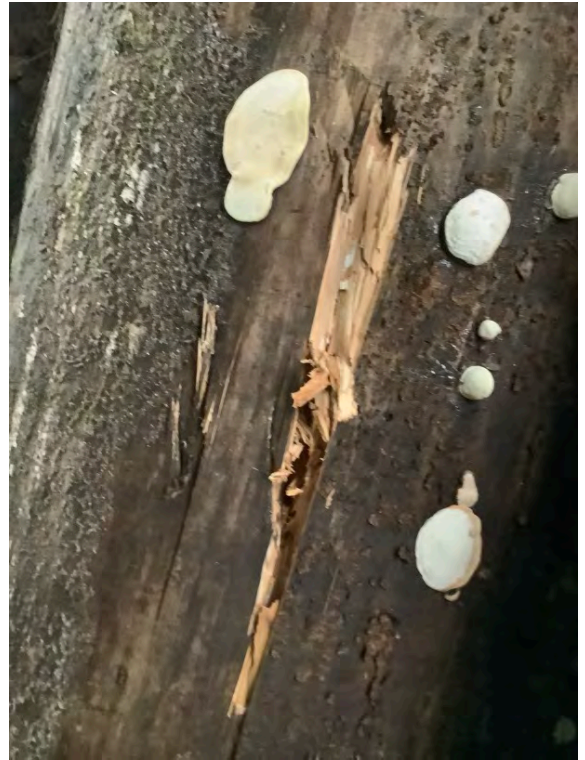
Previous bridge appears to have been overtopped with gravel. Most stringers have advanced decay / konk.

Typical stringer condition
