SC-8359  
SC-8359

## SECHELT CREEK 8.09km

2022 Inspection

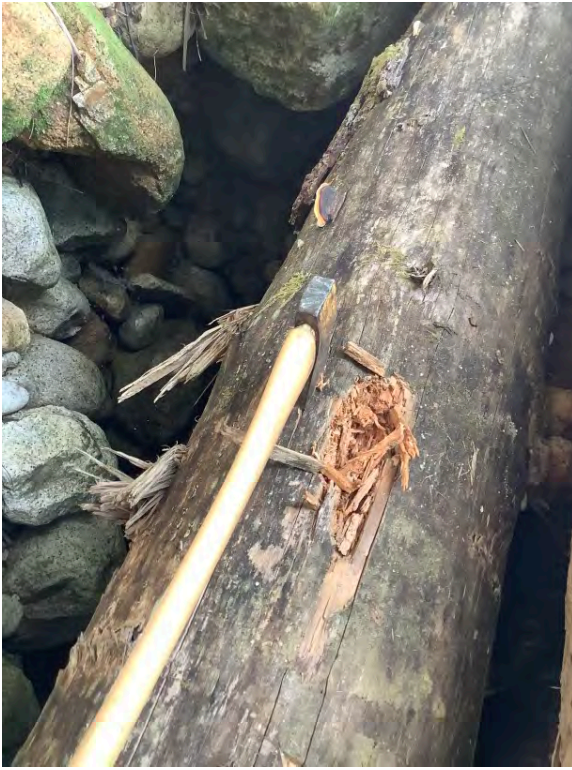
Most stringers have conk / advanced decay. Appears to have been overtopped with gravel and possibly puncheon. ~~Remove bridge and block access.~~

Most stringers have conk / advanced decay.

Stringers - upstream side

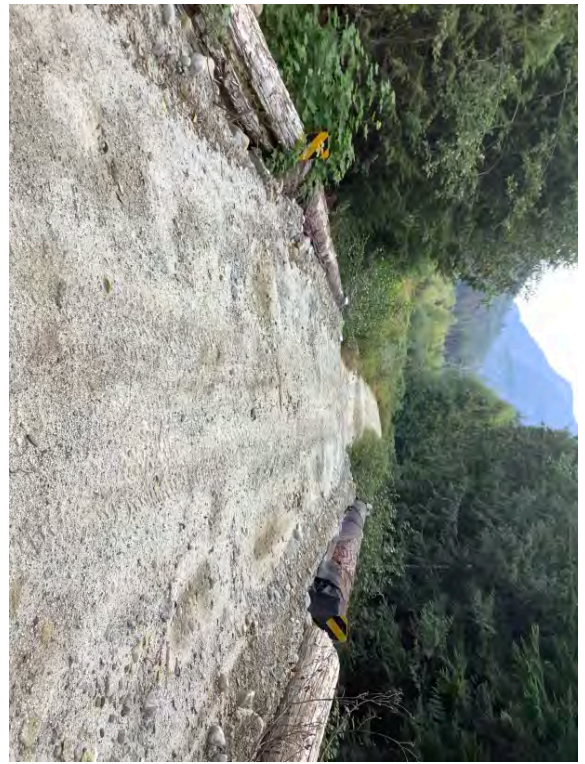
Approach from Right Bank when facing downstream

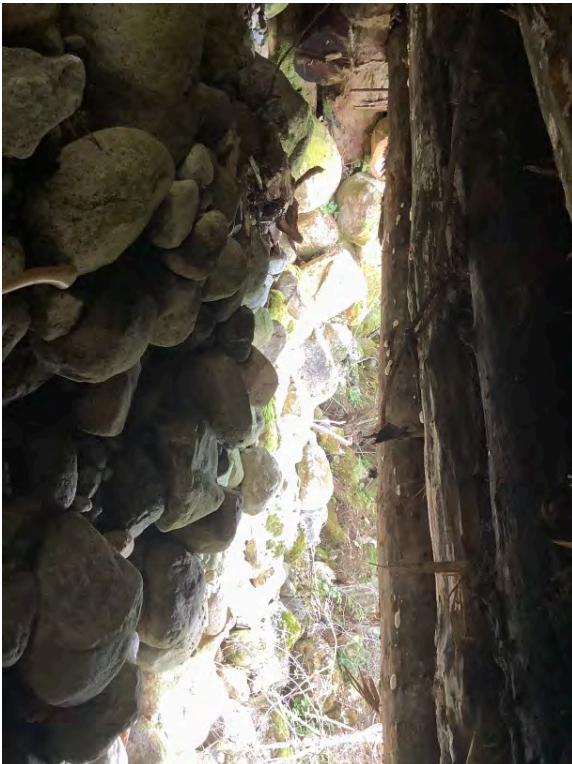
Stringers

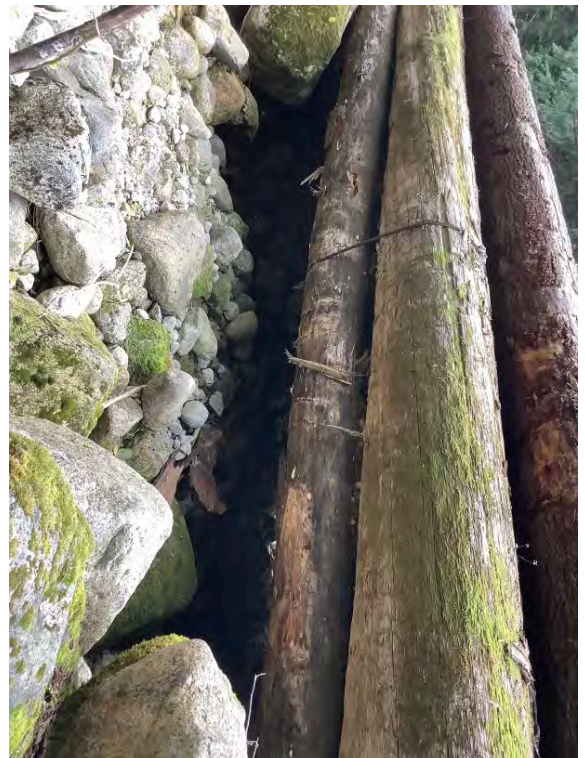
| Comments | Low clearance | | | | |

Upstream Profile - low clearance

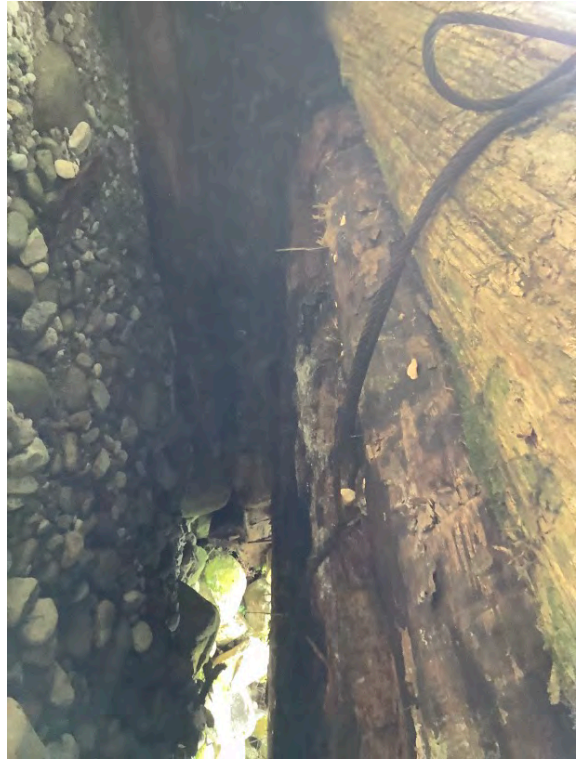
Stringers - downstream side

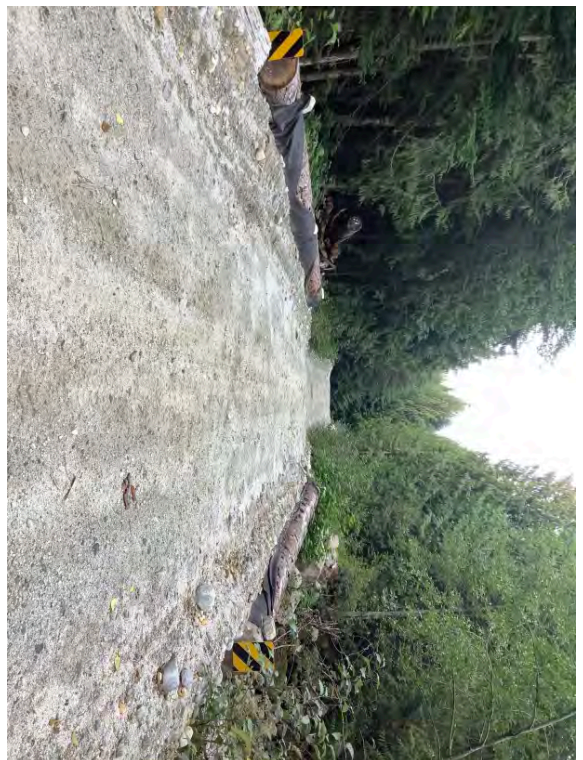
Approach from Left Bank when facing downstream
