SC-8399  
SC-8399

BRITAIN RIVER 1.03km

2022 Inspection

Crossing Name Treth Creek

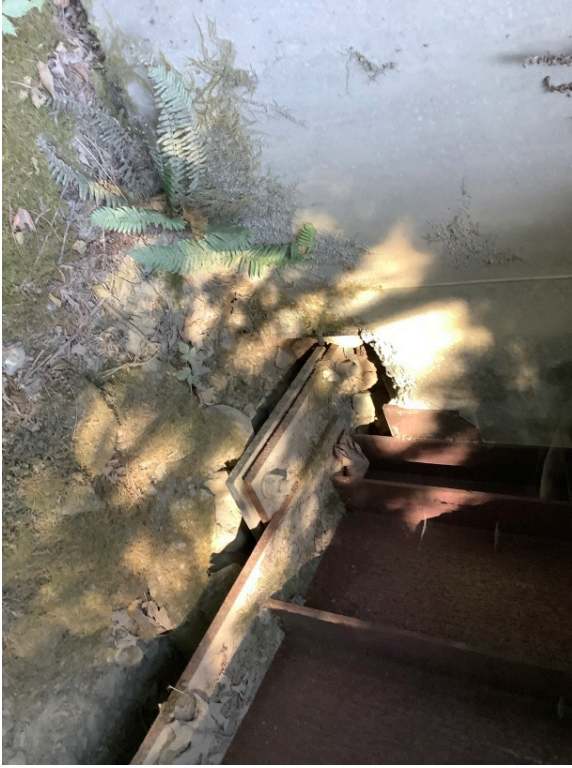
Left Bank Abutment when facing downstream

Caps or Sills **Fair** Girder not bearing correctly as previously detailed.

Ballast Wall **Fair** Broken to fit over cap on right, as previously detailed.

| Item | Monitor Description | Frequency |
|---|---|---|
| 1 | Monitor left abutment (girder, ballast wall) | Routine Inspection |

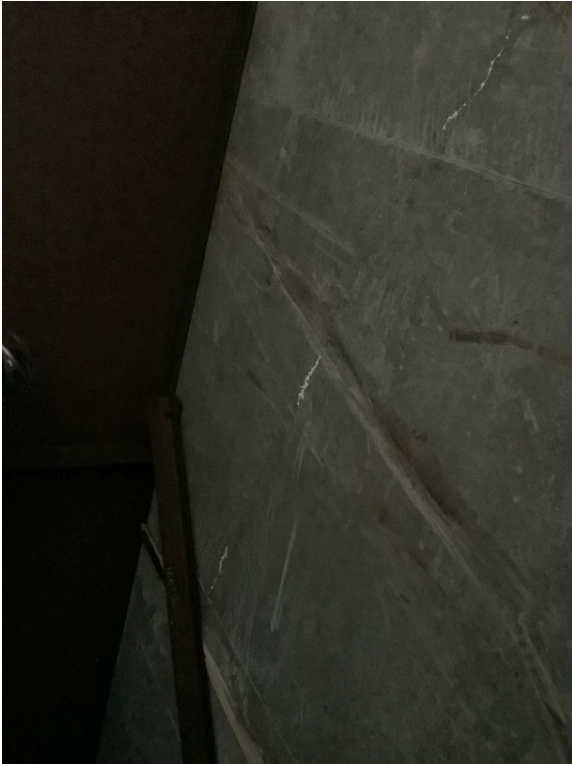
2nd Deck panel from right.

Deck panel (2nd from right side) has 3 small, (approx 200mm long sections) with efflorescence. No rust stain visible. Sections are separated by approx. 1m between them. Not continuous. Cracks are not visible, just efflorescence.

| Item | Monitor Description | Frequency |
|---|---|---|
| 2 | Monitor cracked deck, 2nd panel from end, right side | Routine Inspection |

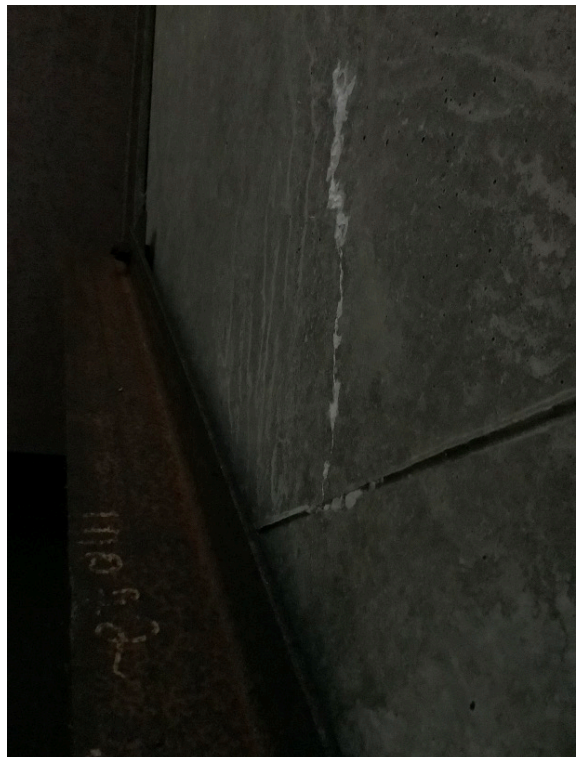
Efflorescence 2nd panel from right
