SC-8559  
SC-8559

## SALTARY-FAIRVIEW 6.3km

2022 Inspection

Structure Class Temporary Bridge

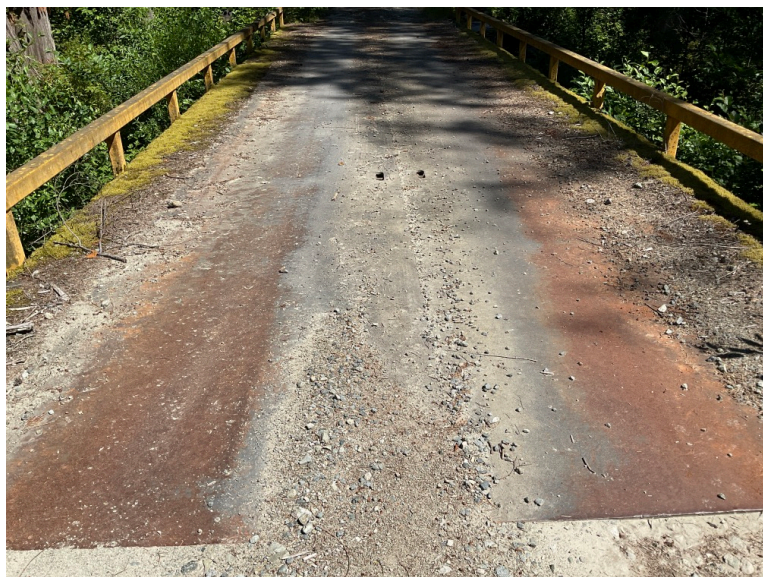
Steel Deck Plate Fair Anti skid worn off

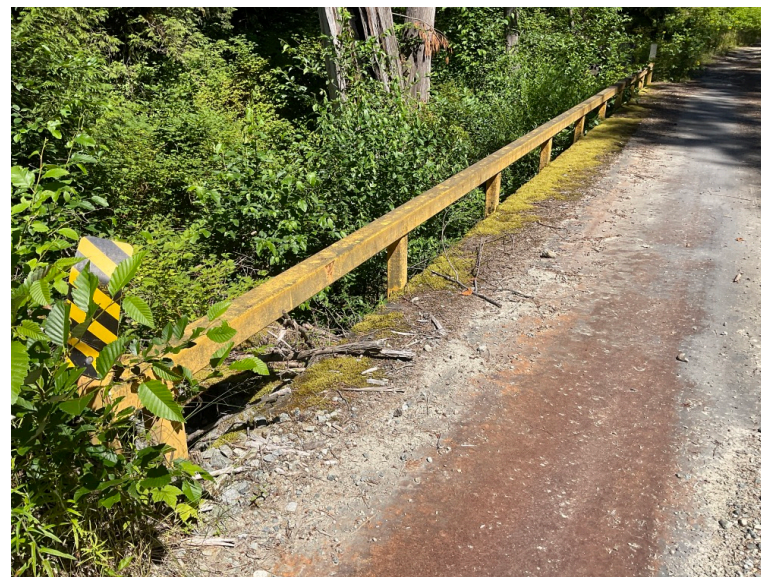
Guard Rail

Curb Rail/Blocks/Posts Fair

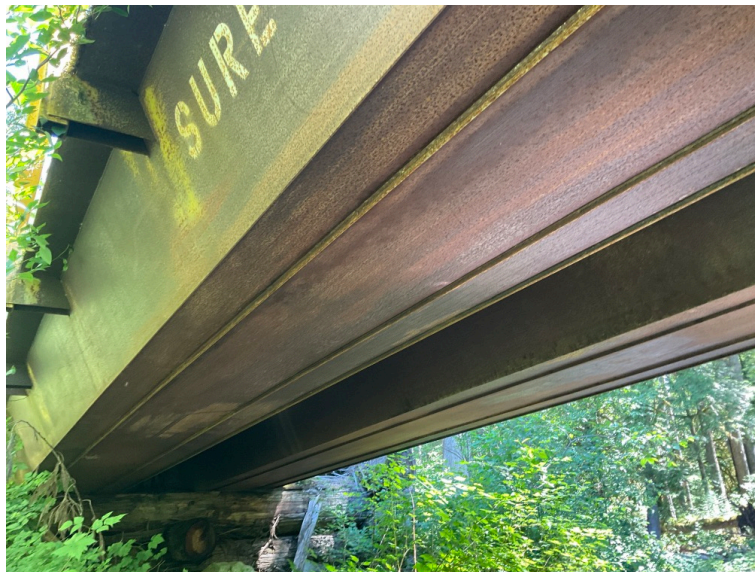
Superstructure

Girders Fair

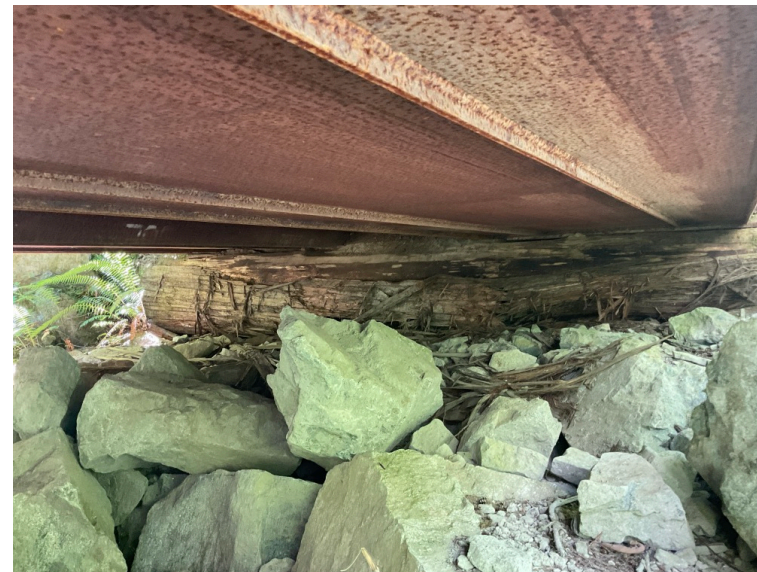
Bearing

Bearings Fair
