SC-8586  
SC-8586

## ST VINCENT 5km

2022 Inspection

Structure Class Major Culvert

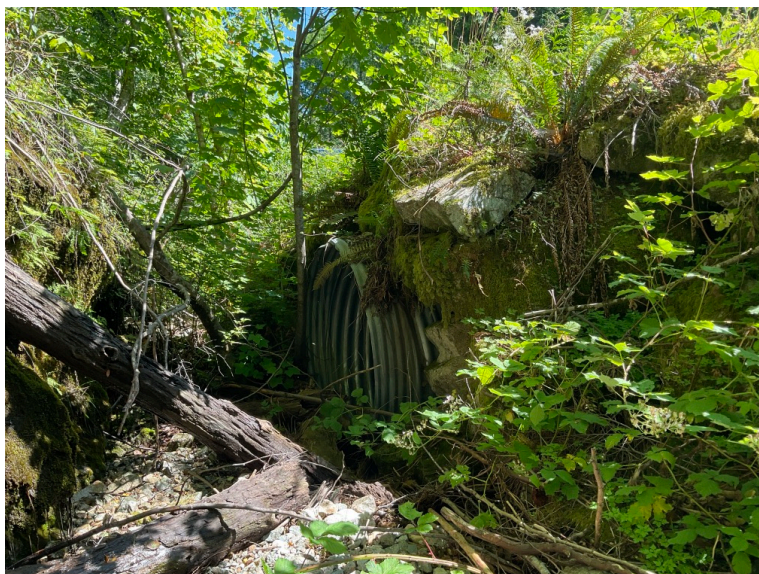
Inlet Fair Minor debris in inlet

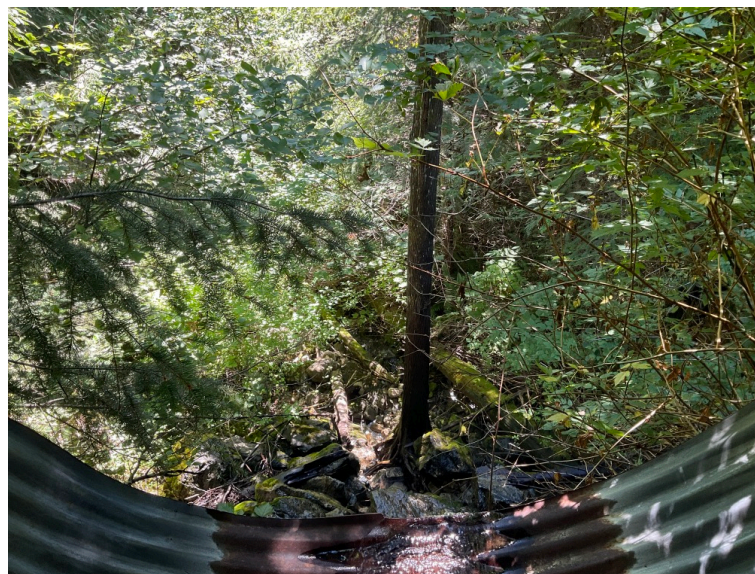
Outlet Fair 3m drop out of outlet

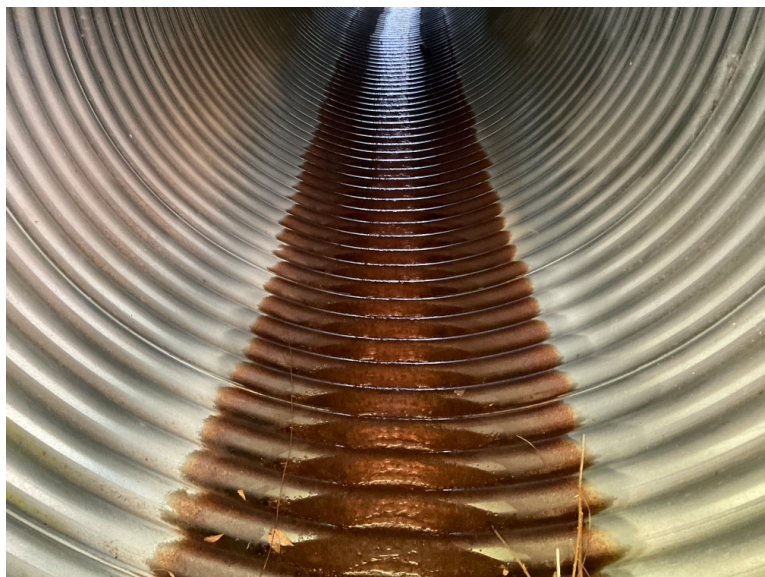
Culvert Floor

Floor Fair Minor corrosion
