SC-8610  
SC-8610A

DUCK LAKE 0.15km

2022 Inspection

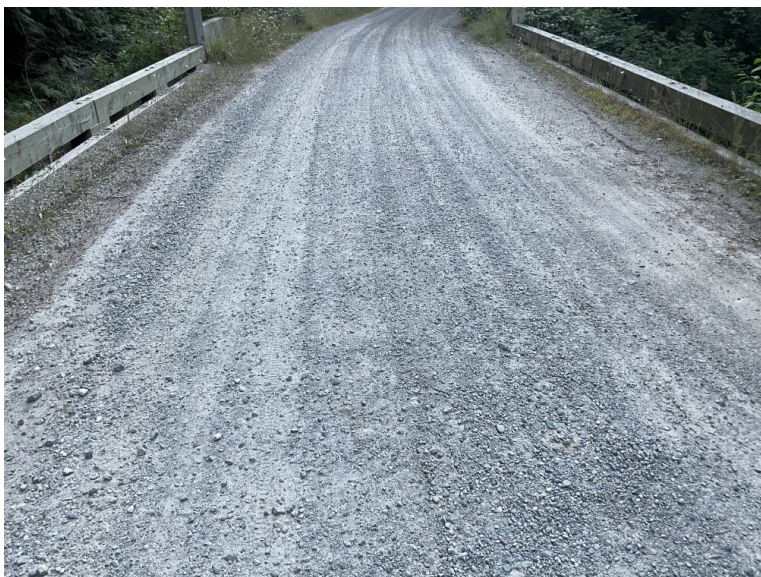
Concrete Deck      Unrated      Covered in gravel

Deck Joints      Unrated      Covered in gravel

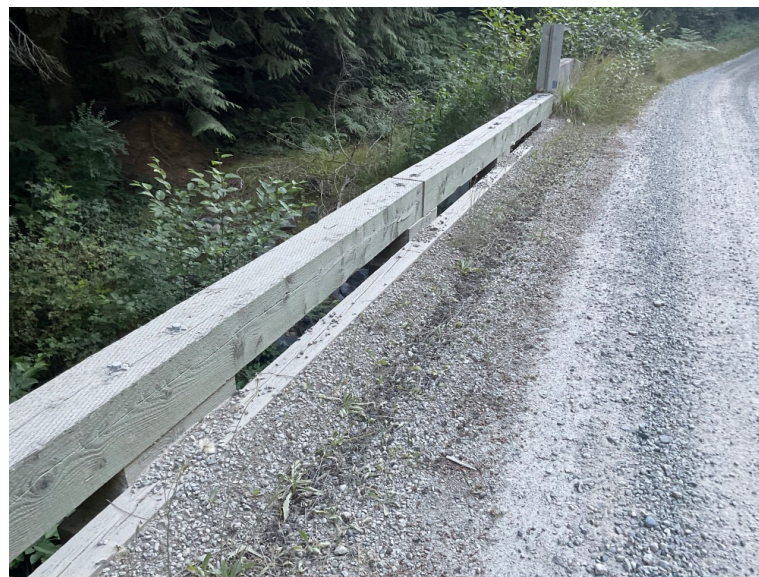
Guard Rail

Curb Rail/Blocks/Posts      Good      Treated timber

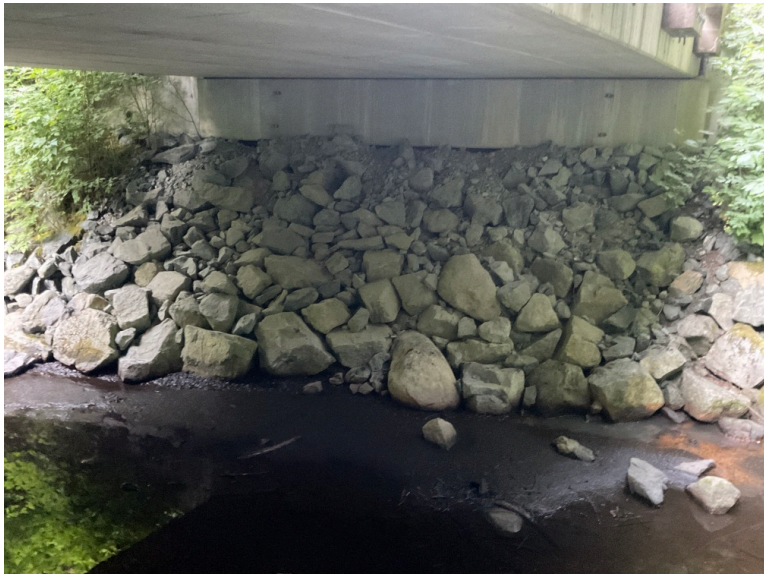
Right Bank Abutment when facing downstream

Riprap Fair

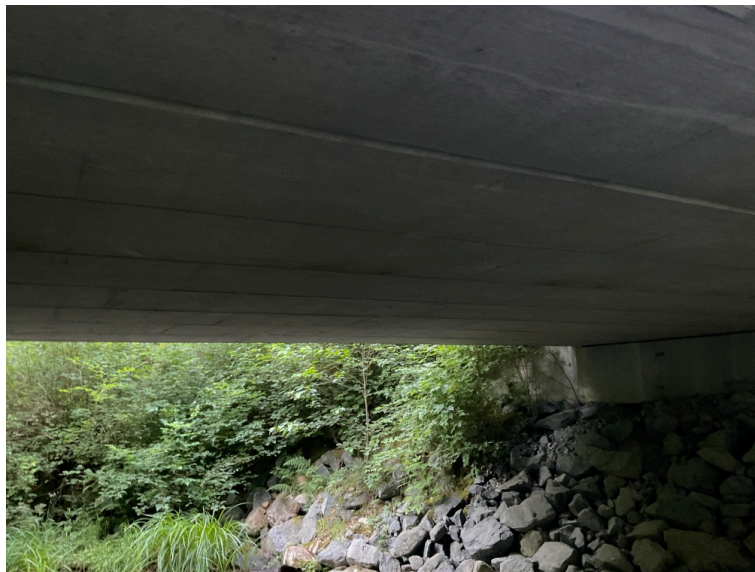
Superstructure

Girders Good

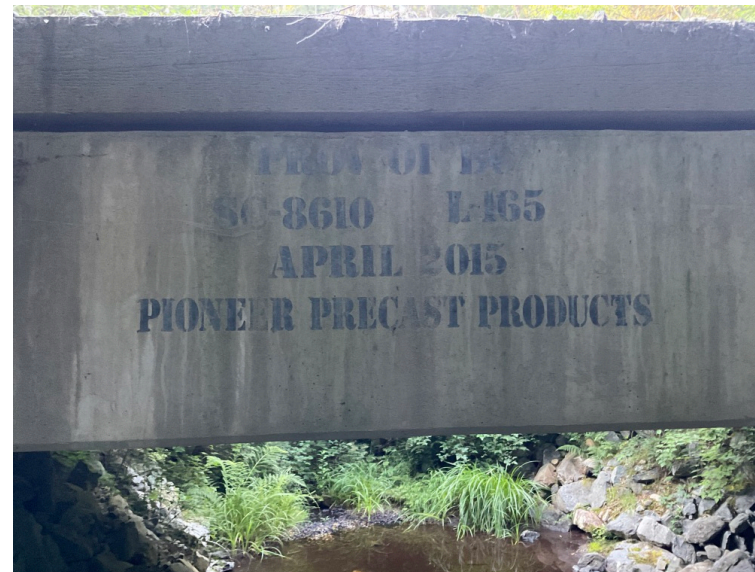
Structure ID

Inspector Comments Serial/ID Plate  
Will require brushing in 2 years maximum
