SC-8620  
PC-030

CM024-006 0.7km

2022 Inspection

Structure Class Temporary Bridge

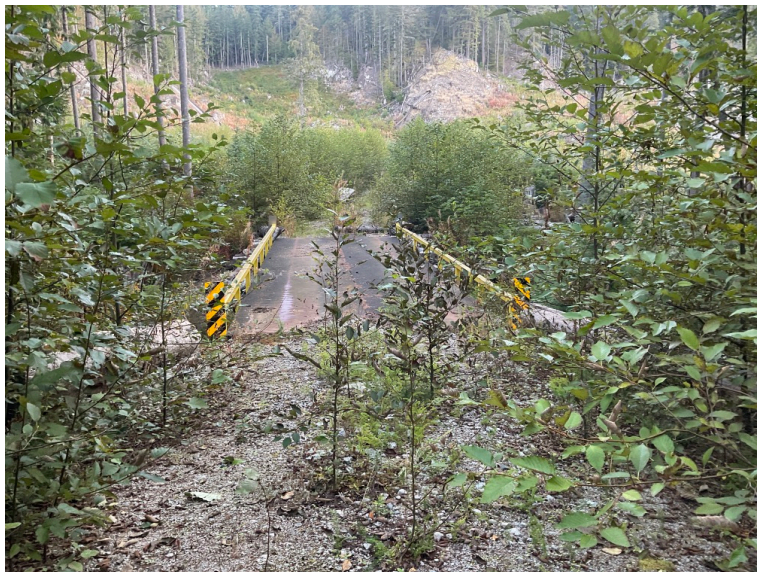
Approach from Left Bank when facing downstream

Delineator Missing  
Left ☒ 0 ☐ 1 ☐ 2 Delineators are mounted backwards

| Repair Item | Repair Description |
|---|---|
| 1 Approach. Area/sight line brushing. 1 m <sup>2</sup> . Priority:Low | Brush out sight lines when active |
| 2 Approach. Add Warning Signs. 4 # of signs. Priority:Low | Reverse delineators to correct sides |

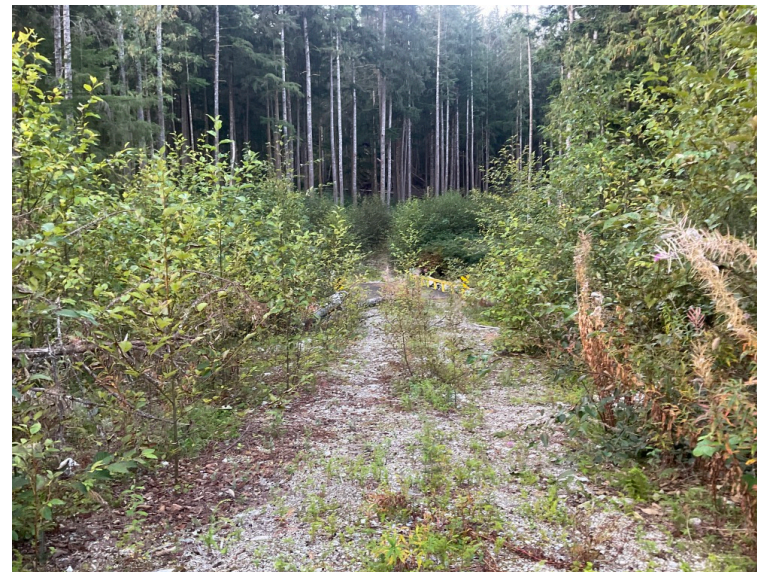
Approach from Right Bank when facing downstream

Delineator Missing  
Right ☒ 0 ☐ 1 ☐ 2 Delineators are mounted backwards

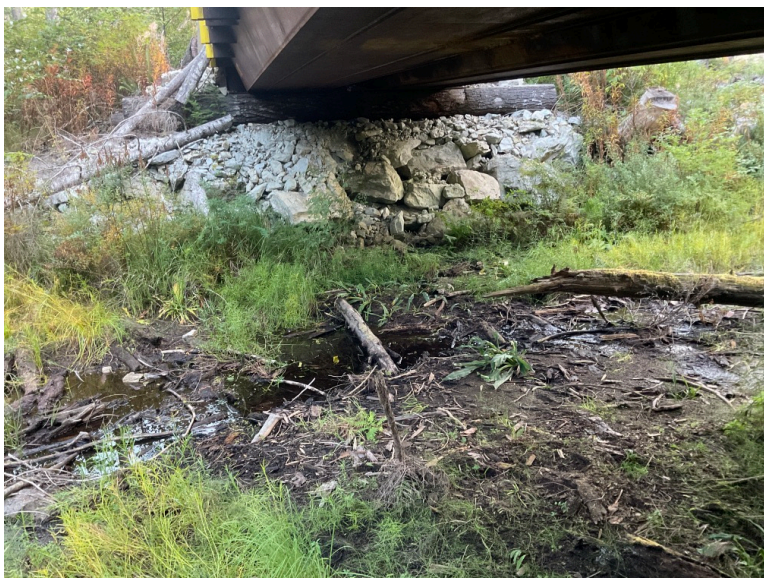
Right Bank Abutment when facing downstream

Ballast Wall Fair Low on right bank
