SC-8635  
SC-8635

MCNAB-POTLATCH 1.5km

2022 Inspection

Structure Class Major Culvert

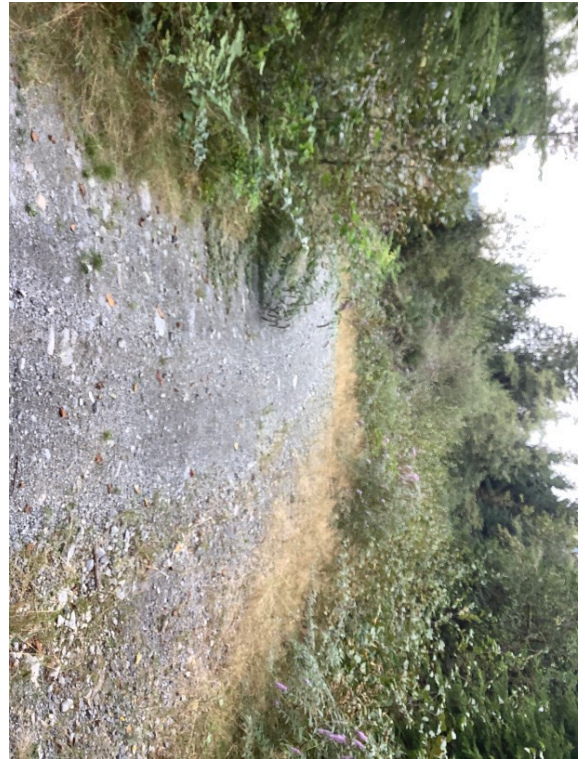
Approach from Left Bank when facing downstream
